Relationship between fracture toughness and porosity of clay brick panels used in ventilated façades: Initial investigation

Marco D'Orazio*, Stefano Lenci, Lorenzo Graziani

Department of Construction, Civil Engineering and Architecture (DICEA), Università Politecnica delle Marche, via Brecce Bianche, 60131 Ancona, Italy

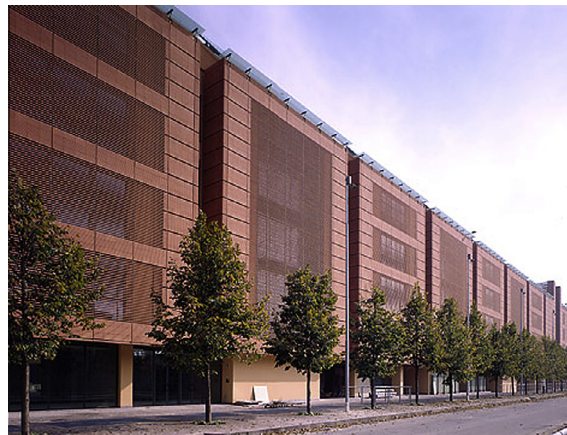
Fig. 1. Bank of Lodi, Renzo Piano Building Workshop.

Some architects recently used this material in a new form. Brick panels were used in some recent buildings as cladding in order to create ventilated façades. In ventilated façades, clay brick elements are connected to a metallic fixing system with metallic clips. Examples of this technology are shown in Fig. 1.
