An interdisciplinary approach to a knowledge-based restoration: The dark alteration on Matera Cathedral (Italy)

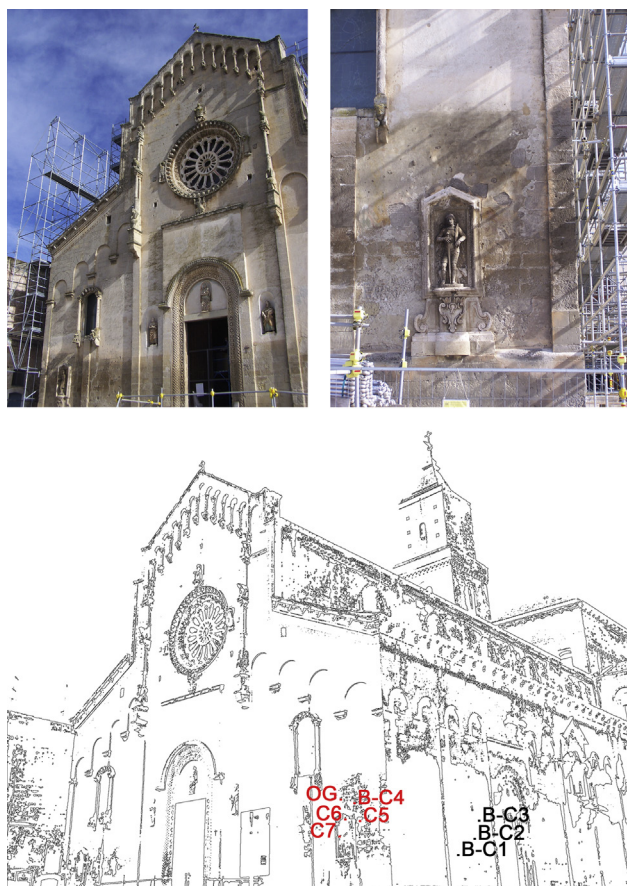
Fig. 1. Facade of Matera Cathedral (Matera, Italy) with the dark alteration in the lower part of the structure (up to 6–8 m) and details of the niche with St. Eustache statue (above). The provenance of the samples (bottom).

The exterior walls of the cathedral are made from the local organogenic limestone. The lower part of the walls (up to 6–8 m) have become darkened since at least the beginning of the 20th century (Fig. 1). This is of major concern because of the serious aesthetic damage to one

Eight samples (C1–C7, OG) of “Pietra di Matera” and mortar (C4 sample) were taken from the stone surfaces of the southern wall and from the façade, both as powder and fragments scraped off the surface using a scalpel (Table 2). Selective sampling of C4 and C6 sample was carried out by a micro-lancet under an optical microscope, in order to analyse the three and two layers of the stratigraphy, respectively. The samples of powders for the biological analyses (B1–B4) were scraped off the surface with a sterile chisel (Table 2). Fig. 1 shows the sampling points.
