Variations in the composition and relations between alkali-silica gels and calcium silicate hydrates in highway concrete

Frýbort A.^a, Všianský D.^{b,*}, Štulířová J.^a, Stryk J.^a, Gregerová M.^{a,b}

^a Transport Research Centre, Líšeňská 33a, 636 00 Brno, Czech Republic

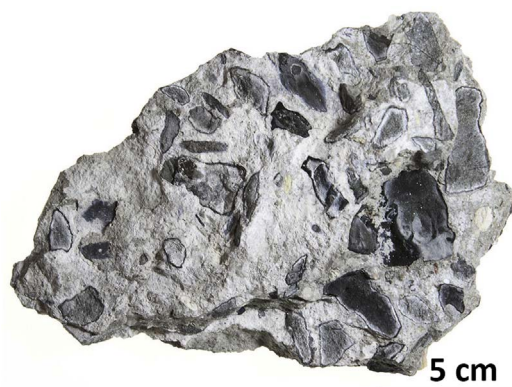
Fig. 1. Macroscopic appearance of the examined concrete.

The subject of the study are concrete cover blocks (CCB) with the dimensions of ca 6×3.7 m, which were placed below the surface of a highway and exposed to the traffic for 18 years. Drill cores (15×30 cm) and edge fragments of the CCB were examined. Samples were systematically extracted from the drill cores with steps of 10 cm. Marked polygonal cracks were found in the surface. Macroscopically, the parts that showed the most damage were rim areas around majority of the aggregates (Fig. 1), however the gels can penetrate rock fragment as well.
