Applied Mathematical Modelling

Dynamic assessment of partially damaged historic masonry bridges under blast-induced ground motion using multi-point shock spectrum method

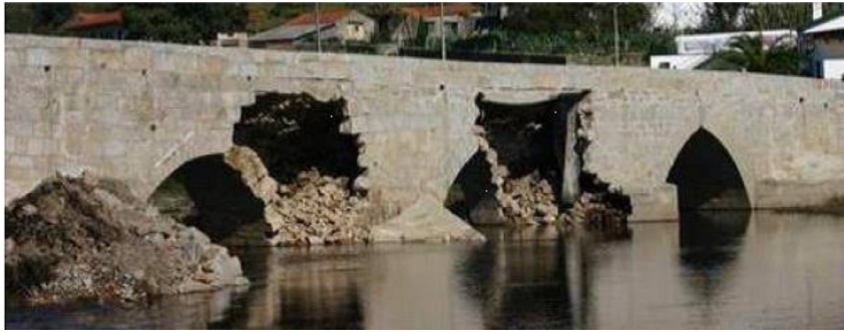
Fig. 1. Upstream view of collapsed arches and piers [1].

A few partially damaged or destroyed bridges have been illustrated. Fig. 1 shows the D. Zameiro Bridge, located about 40 km north of Porto, in the northern part of Portugal [1]. The bridge was closed in March 2001 because of existing damage. This was partial collapse of a pier, longitudinal cracks along the intrados of some arches, either on the upstream or downstream sides, material degradation, the presence of cement mortar in some joints and absence of mortar in other joints, inter alia.

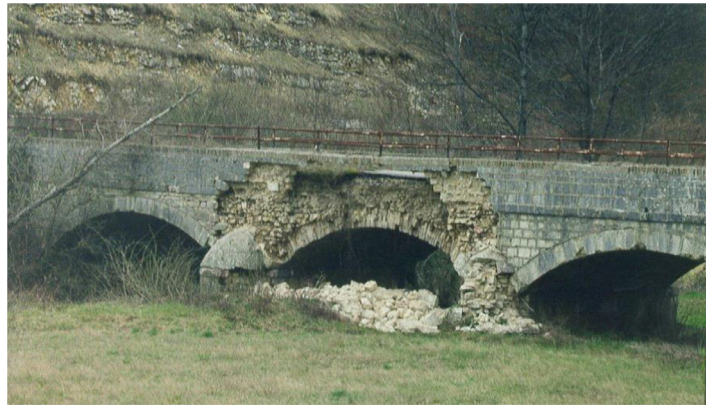
Fig. 2. Damage of a masonry bridge [3].

In Fig. 2, a masonry arch bridge is shown, which was damaged during the 1997 Umbria and Marche earthquake occurred in the regions of Umbria and Marche, central Italy on the morning of September 26. The collapse of the central span arch wall, as well as the exposure of the arch filling material, are possible failures such as the partial out-of-plane collapse of the arch walls [2,3].

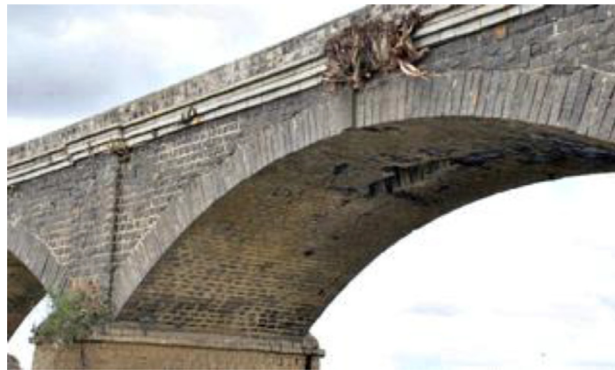
Fig. 3. Kurikota bridge [4].

Finally, one of the arches of the bridge was damaged, as some of the stones in the structure fell off (Fig. 3) [4].
