The use of copper-based antifouling on aluminium ship hulls

Frank Bagley^{a,*}, Mehmet Atlar^a, Alasdair Charles^a, Colin Anderson^b

^a Newcastle University, United Kingdom

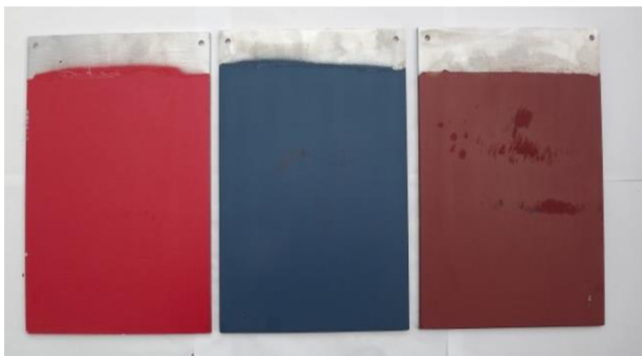
Fig. 1. Sea plates before immersion. (Left AF, middle SPC and right CDP).

The seawater immersion tests were carried out on the three plates cut to a size of 300 mm × 205 mm. These plates were coated with the three different antifouling paints using airless spray

under ambient conditions, to the thickness recommended by the paint manufacturer (*International Paint*). The antifouling was applied directly to the bare aluminium, without any primer, which is not recommended by the manufacturer but for the experiment this would simulate the worst case scenario of the antifouling being in direct contact with the aluminium substrate, rather than scribing. Scribing without a primer applied would simply create a crevice which is susceptible to corrosion. Also scribing an antifouling coat that has a primer applied will allow water to penetrate under the coating and detach the coating system, and this would result in the experiment failing. A strip of aluminium was left uncoated at the top of the panel, 20 mm high and 205 mm wide, as shown in Fig. 1. This was intended to show if any copper leaching from the antifouling deposited on the bare aluminium substrate and would also simulate a creation of a holiday in the coating. In addition one completely bare and uncoated control plate was also used for comparison. The plates were immersed to a depth of 2–3 m and secured to the jetty in a series 2 m apart in the North Sea (*Blyth harbour, North East of England*) for a total of 88 days during December 2013–March 2014.

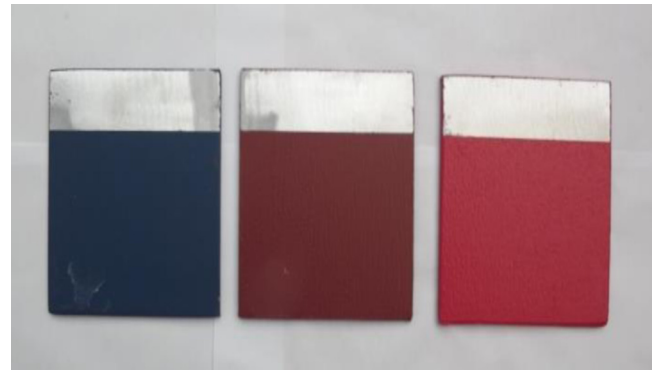
Fig. 2. Laboratory plates before immersion. (Left SPC, middle CDP and right AF).

A controlled laboratory experiment was also set up identical to the sea water immersion experiment but with 100 mm × 100 mm size plates, and a 20 mm × 100 mm strip of bare aluminium, as shown in Fig. 2. This test was undertaken to see if similar results could be achieved in a controlled laboratory experiment. The specimens were placed in a plastic rack 100 mm apart and placed in a bath 350 mm wide 700 mm long and 200 mm deep. This was filled with 25 l of distilled water and sea salt (35 g l⁻¹) with the temperature set at 34 °C to increase the reaction time of any corrosion. A layer of polystyrene foam pieces was used to cover the water surface of the bath to reduce heat loss and to limit evaporation. The laboratory specimens were placed fully immersed in the bath for 8 days.
