Surface analysis of metal alloys exposed to geothermal fluids with high non-condensable gas content

Nine types of carbon steels and corrosion resistant alloys (CRA) were exposed to high enthalpy geothermal fluid with high non-condensable gas content (NCG). Surface evaluation showed that Carbon steel sustained relatively high corrosion rates (> 0.15 mm/y). Scales completely covered the surface of most of the other coupons and consisted of 33–35 μm thick micro-crystalline iron sulfides outer layer and iron oxides, sulfides and silica inner layer. CRA's were immune to uniform corrosion. However, the duplex stainless steel 2205, Alloy 825 and Alloy 59 suffered crevice corrosion. Thin (~ 4 μm) scales were observed in most of the CRA's with high concentration of chromium and nickel.

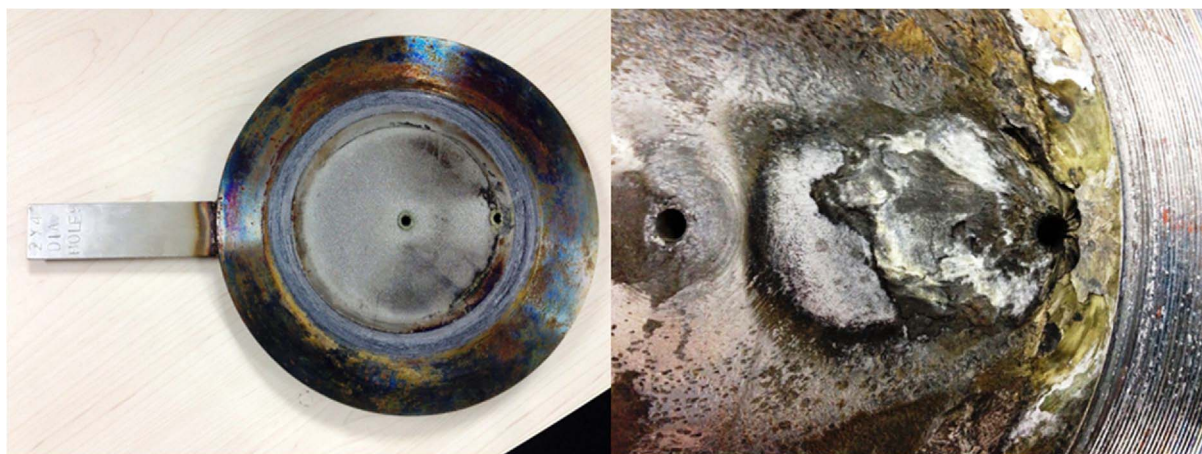
Fig. 1. Photo of the back-pressure orifice plate installed at well XH-01. The orifice plate is 10.16 cm (4 in.) in diameter. Right photo shows the enlarged view of the damage near the drain orifice.

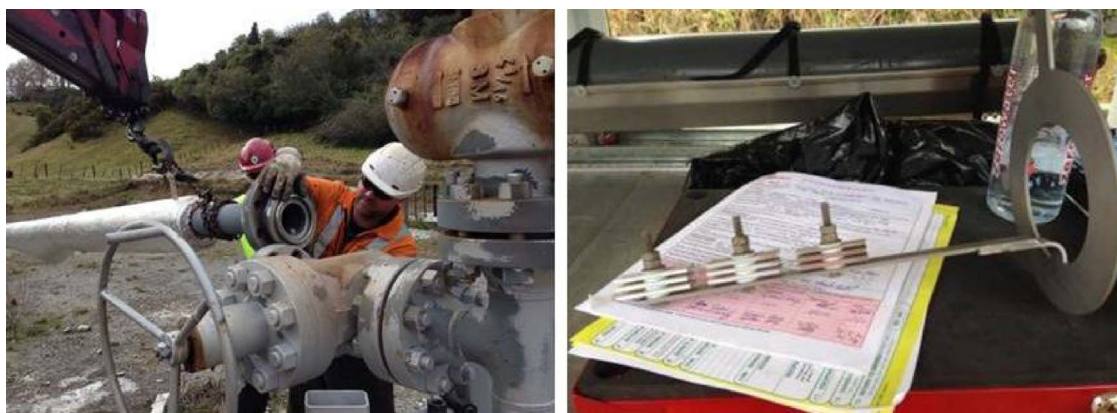
Fig. 2. CL900 RTJ Flange (left) where the corrosion rack (right) was installed.
