International Journal of Rock Mechanics & Mining Sciences

Examination of rockbolt stress corrosion cracking utilising full size rockbolts in a controlled mine environment

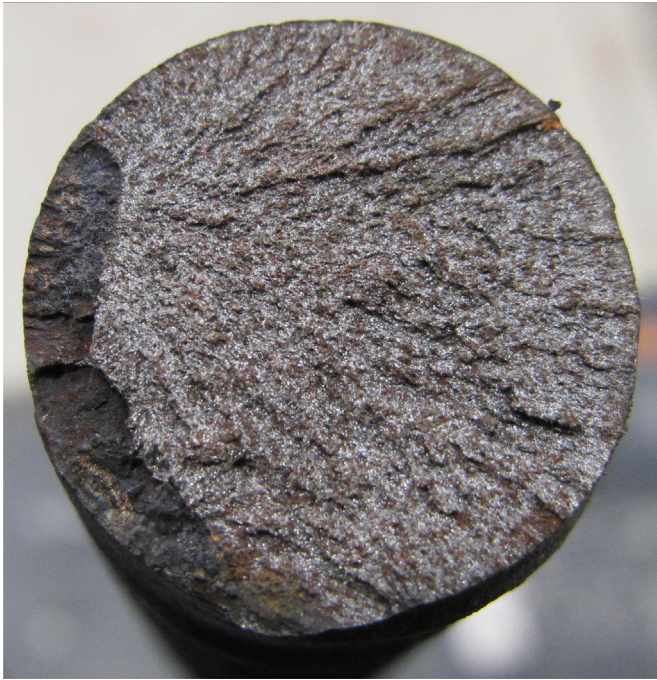
Fig. 1. A rockbolt affected by SCC. The area of initial crack growth can be seen as the dark brown section on the left hand edge of the failure surface. On this rockbolt, several cracks have initiated simultaneously and have overlapped during their growth. The remaining failure surface can be seen as speckled silver and grey, indicating brittle fracture.

Stress corrosion cracking (SCC) is a material failure mechanism characterised by the growth of fine dendritic cracks through the cross section of a material. SCC occurs when a susceptible material is exposed to a corrosive environment while subject to a high tensile stress. The resulting crack growth is orthogonal to the direction of applied stress, and continues until it is of a sufficient length to result in the catastrophic failure of the material by mechanical overload that is characterised by brittle fracture. SCC is not necessarily accompanied by significant surficial corrosion and is thus, easily overlooked in general inspection of engineering structures. Its insidious nature means that its impact on the mining, energy and construction industries, as well as the economy at large, is likely to be underestimated [1]. The typical fracture surface of a rockbolt that failed due to SCC can be seen in Fig. 1.
