## Renewable and Sustainable Energy Reviews

## Sediment erosion in hydro turbines and its effect on the flow around guide vanes of Francis turbine

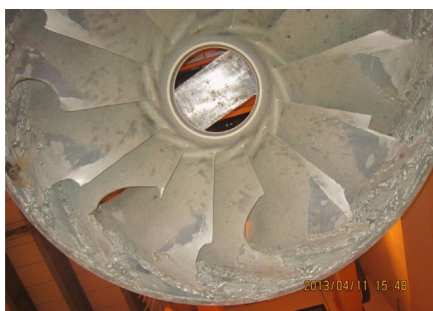
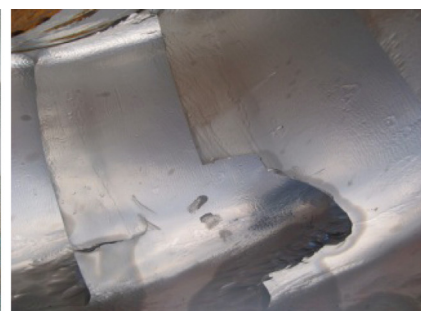
Fig. 2. Sediment erosion in Francis turbine runners from various Power plant.

48 MW\*3 Francis turbine at Kaligandaki Power plant, Nepal [5]

250 MW\*6 Francis turbine at Nathpa Jhakri Power plant, India [6]

23 MW\*2 Francis turbine at Chawa Power plant, Peru [7]

Similar cases of sediment erosion of turbine components and associated losses have been reported from power plants from India [9], Bhutan [10] and also from South American continents [7]. Fig. 2 shows typical damages of hydro turbine components from different power plants operating under heavy sediment load. Comparable patterns of turbine erosion, operational challenges and performance losses have been observed from different power plants, operating in sediment environment, across the continents.
