The Journal of Foot & Ankle Surgery

Metatarsal Periosteal Plantar Ganglion Cyst Associated With Stress Fracture: A Case Report

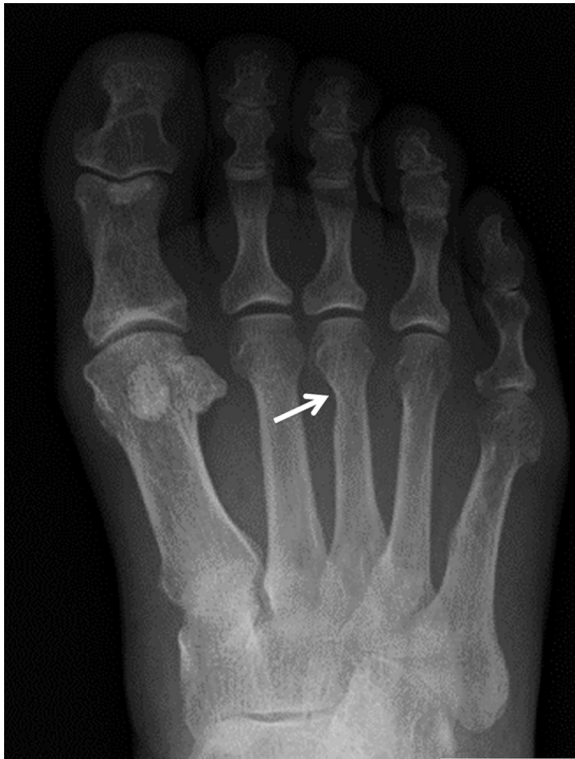
Fig. 1. Radiograph of the right foot showing an erosive cortical lesion at the third metatarsal neck (white arrow).

the foot was observed. Radiographic examination revealed an erosive cortical lesion at the third metatarsal neck (Fig. 1). Magnetic resonance imaging (MRI) revealed a cystic mass between the plantar aspect of the second and third metatarsals showing low signal intensity on T1-weighted images and high signal intensity on T2-weighted images. Adjacent to the cystic lesion, the third metatarsal generally showed high signal intensity on T2-weighted images (Fig. 2). Quantitative ultrasonography revealed that the bone mineral density was 75% of the mean for young adults.

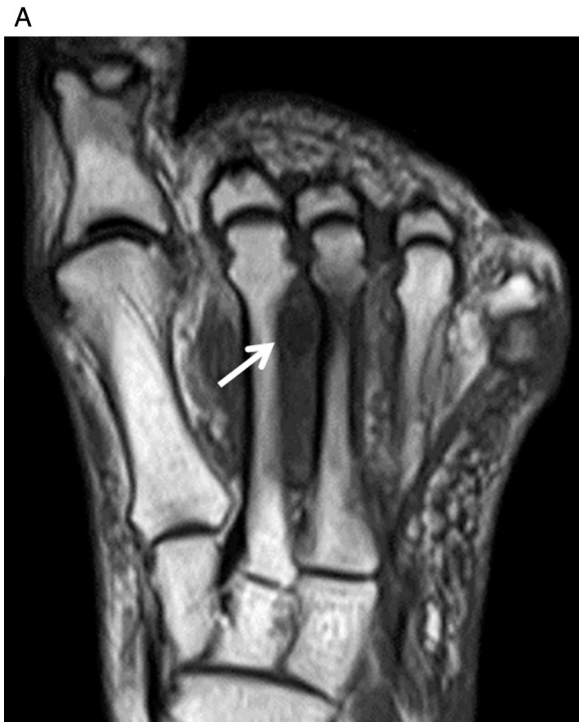
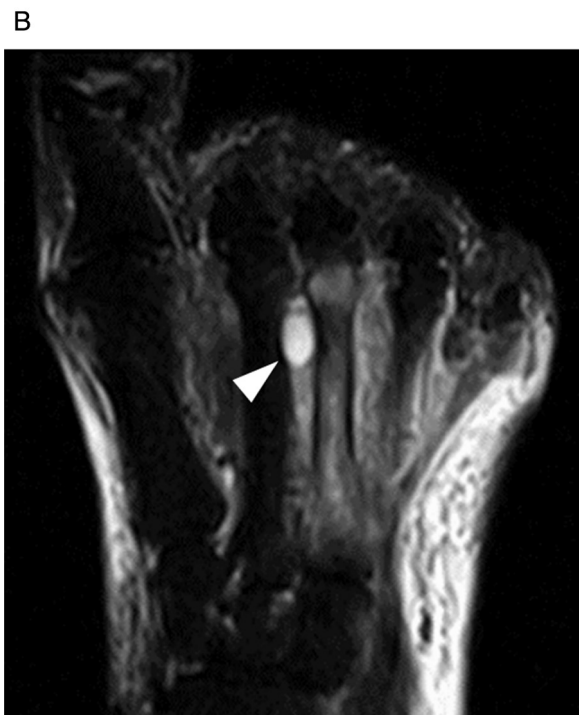
Fig. 2. Magnetic resonance imaging scans of the right foot. (A) T1-weighted image showing low signal intensity (white arrow) at the third metatarsal neck. (B) T2-weighted image showing a high-intensity cystic mass lesion (arrowhead) between the second and third metatarsals with high signal intensity of the whole third metatarsal.

cortex, or a periosteal reaction (14). In the present case, plain radiography showed an erosive cortical lesion at the metatarsal neck, and MRI showed a stress fracture and a ganglion cyst. The characteristic clinical feature of periosteal ganglion cysts is that the mass is not movable on the underlying floor and shows no signs of
