Lingual mandibular osteonecrosis after dental impressions for orthodontic study models

Carmen Cerruto,^a Alessandro Ugolini,^b and Mauro Cozzani^c
Siena and Genova, Italy, and Smart City, Malta

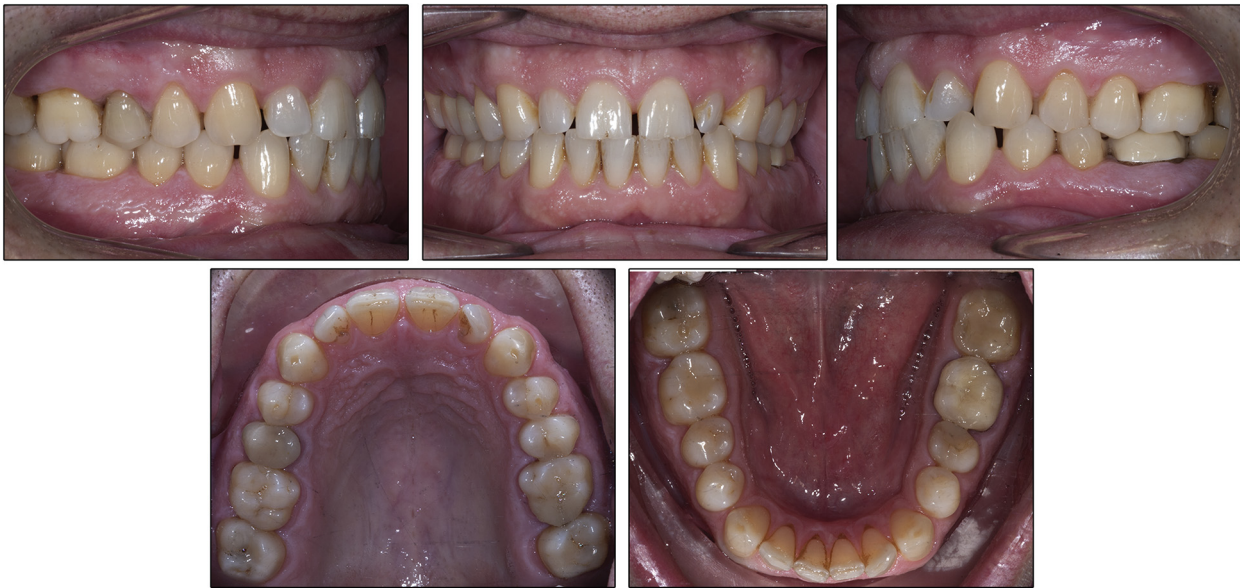
Fig 1. Intraoral images of the patient.

A 43-year-old man seeking improvement of his smile was referred by his general dentist to an orthodontist (C.C.) at his private practice in Almere in the Netherlands, to correct his malocclusion and allow for the placement of 6 veneers in the maxillary anterior area. He had a dental Class I malocclusion, mild skeletal Class III pattern, reduced overjet and overbite, and anterior spacing (Fig 1).

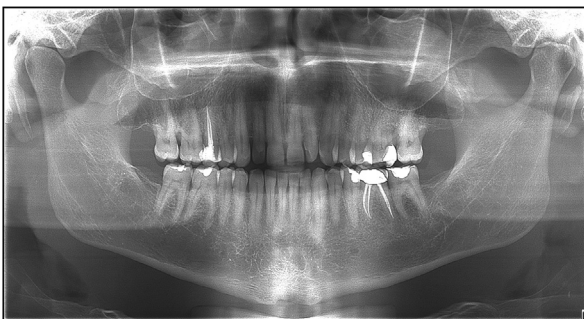
Fig 2. Orthopantomogram.

During the initial orthodontic consultation, intraoral and extraoral photos were taken, together with an orthopantomogram (Fig 2), a lateral telerradiograph (Fig 3), and alginate impressions for the orthodontic study models.
