# Mandibular implant-retained overdenture relining procedure with an attachment system

A step-by-step demonstration of the technique

JADA 2018;149(1):67-71

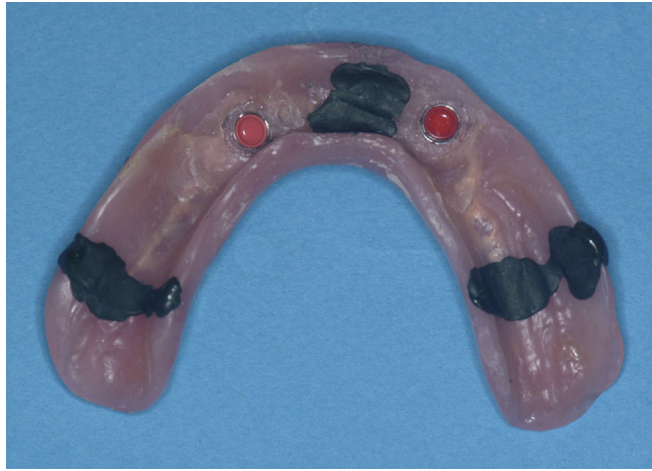
**Figure 1.** Fitting surface of the overdenture with 3 tissue stops.

- Remove all large undercuts and a thin layer from the tissue surface of the denture.
- Create tissue stops by using low-viscosity modeling compound impression material (Impression Compound Green, Kerr), which is placed in 3 regions of the denture's fitting surface (second molars and between the 2 canines) (Figure 1). The tissue stop is mainly to maintain the vertical dimension of occlusion when obtaining the impressions, but in some cases, like this, in which visual examination and use of a pressure indicator material (Mizzy, Keystone Industries) reveal underextended posterior borders, the material might extend to the denture borders as well. Thus, we achieved the bolder molding of the denture by using the low-viscosity modeling compound impression material.<sup>5</sup>
