Case Report

Distal tibial metaphyseal allograft cone for proximal tibial bone loss in revision knee arthroplasty – A novel technique

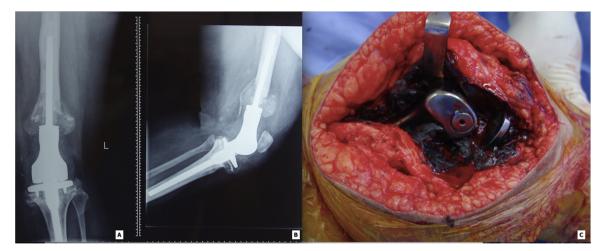
Fig. 1. X-ray of left knee in Anteroposterior view [A] and Lateral view [B] showing the failed megaprosthesis in situ. Intraoperative picture [C] of the same knee showing severe metallosis around the knee joint. The capsule was thickened with hypertrophied synovium densely tinged with black metallic particles.

A 43-year-old female patient was operated for fracture of left distal femur with plating 9 years back which not only failed to unite at one year, but also developed osteoarthritis of knee. Total Knee Arthroplasty was done with megaprosthesis (Adler's knee prosthesis) after removal of the plate (Fig. 1A & B). She remained asymptomatic till 9 years then after when she presented to our institute with complaints of pain, swelling and inability to bear weight on left lower limb for 4 months. On examination, the knee joint was diffusely swollen and tender with normal temperature. Anteroposterior radiograph of left knee showed a loose prosthesis. On investigation, the ESR was raised (55 mm in first hour), C reactive protein (CRP) level was within normal limit (1.8 mg/ L). Magnetic resonance imaging could not be performed because of metal prosthesis in-situ. A clinical diagnosis of infection was suspected and aspiration of joint fluid was performed. However, the aspirated fluid did not reveal any bacteria and culture was sterile on microbiological evaluation. The patient was planned for revision surgery. In view of anticipated massive bone defect and yet possibility of low grade infection, the patient was counselled and taken for two stage revision

Operative procedure stage 1: The knee was approached through one of the previous incision and arthrotomy done via medial para-patellar incision. Intraoperatively, dense black tissue was seen all around the joint with synovial proliferation (Fig. 1C). The implant was found to be loose. On examination, link of the prosthesis was worn-out and we suspect the same to be the source of metallosis. Prosthetic components were extracted and the bone ends and surfaces were debrided. The

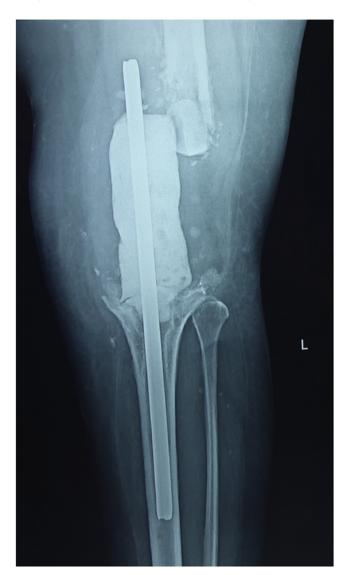
Fig. 2. X-ray of the knee following first stage debridement. Note the cement spacer nail in situ. The proximal end of the nail had cut out of the distal end of femur which was seen before the second stage surgery.

intramedullary debris was removed by curette and reamers. Care was taken to preserve as much bone as possible. The wound was thoroughly washed with pulsatile lavage. A static cement spacer over a K-nail was bridged across the distal end of femur and proximal end of tibia (Fig. 2). Patient was kept under follow-up. Histological evaluation of specimens retrieved at revision surgery demonstrated metallosis. The extracted implant was sent for sonication and did not grow any organism.

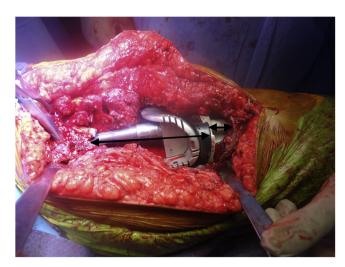
Fig. 3. Intraoperative picture showing trial implants in situ. Arrows showing the bone defect in the distal femur and well as proximal tibia.

Operative procedure stage 2: After 6 months of the first stage surgery, the patient was planned for stage 2 revision. The knee was approached through previous incision and the K nail with cement spacer was removed. The bones were prepared for femoral and tibial components with stem. Large defects were seen in the distal femur as well as the proximal tibia (Fig. 3). There was a large segment defect in the distal femur which we had anticipated preoperatively. In addition, there was a large contained defect in tibia surrounding the keel of the prosthesis classified as type 3 According to Anderson Orthopaedic Research Institute classification. As the collaterals were absent, we planned to reconstruct the knee with following:
