## Acta Orthopaedica et Traumatologica Turcica

## Brown-Sequard syndrome caused by hyperextension in a patient with atlantoaxial subluxation due to an os odontoideum

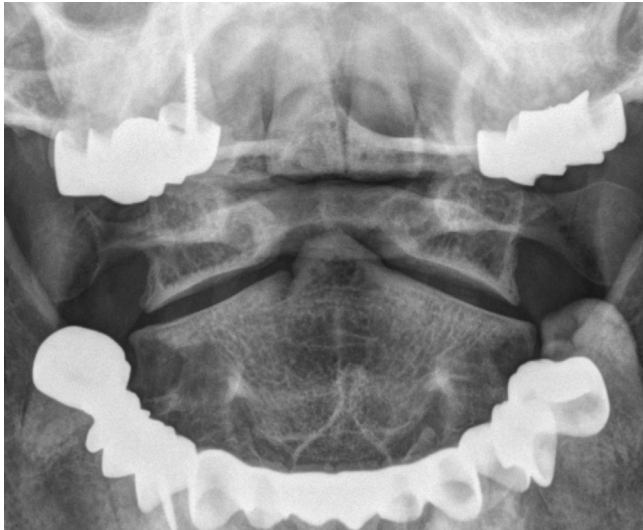
**Fig. 1.** Radiographs of the cervical spine revealing a type II odontoid process fracture.

Radiographs of the cervical spine revealed a type II odontoid process fracture (Fig. 1). There was no vertebral anomaly. She was initially managed conservatively with a Philadelphia neck collar. The CT scan revealed bone resorption with sclerotic changes at the odontoid fracture site; we diagnosed this as os odontoideum. Os odontoideum is an anatomic variant of the odontoid process of C2 that can be associated with atlantoaxial instability; it must be differentiated from persistent ossiculum terminale or an odontoid fracture. The etiology of os odontoideum in this case was unclear; however, we assumed it as a congenital lesion due to the lack of prior cervical trauma history. We also carefully conducted a flexion/extension dynamic CT scan. The space available for the spinal cord was measured and C1-2 instability was confirmed (Fig. 2). The Power's ratio of this patient was 0.9, which would indicate that there was no atlanto-occipital instability. In order to evaluate the patient's neurologic symptoms (causalgia), the patient underwent MRI, which revealed acute spinal cord injury (SCI) at the C1-2 level (Fig. 3). Thus, we finally diagnosed chronic C1-2 instability with acute SCI and planned to perform a C1-2 arthrodesis with screws and rods. Using Harms technique, which has been previously well

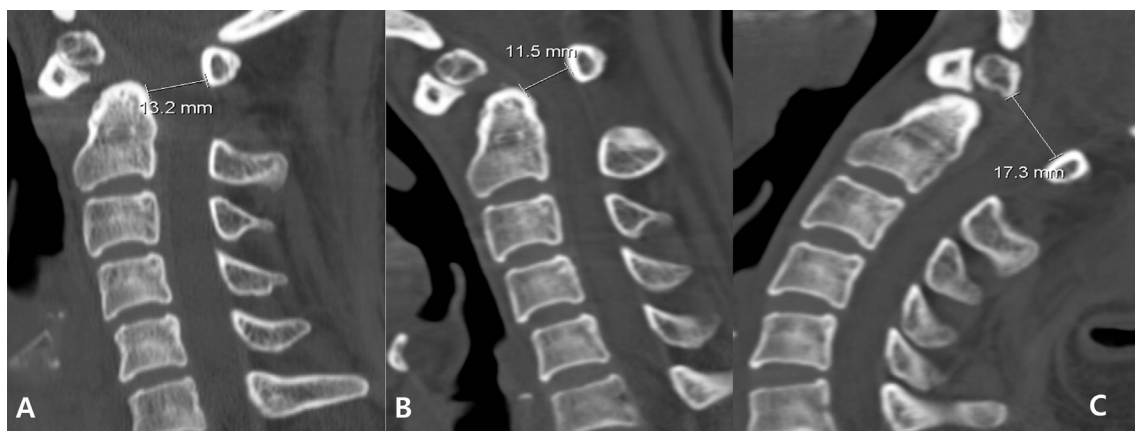
**Fig. 2.** Sagittal CT scan of the cervical spine showing nonunion of the odontoid process (Os Odontoideum) (A). Flexion/extension dynamic CT scans showing chronic C1-2 instability (B, C). Figures of each image indicate the amount of space available for the spinal cord.
