Arthroplasty Today

Case report

Early failure with massive metallosis and posteromedial wear following atraumatic anterior cruciate ligament rupture after medial unicompartmental knee arthroplasty

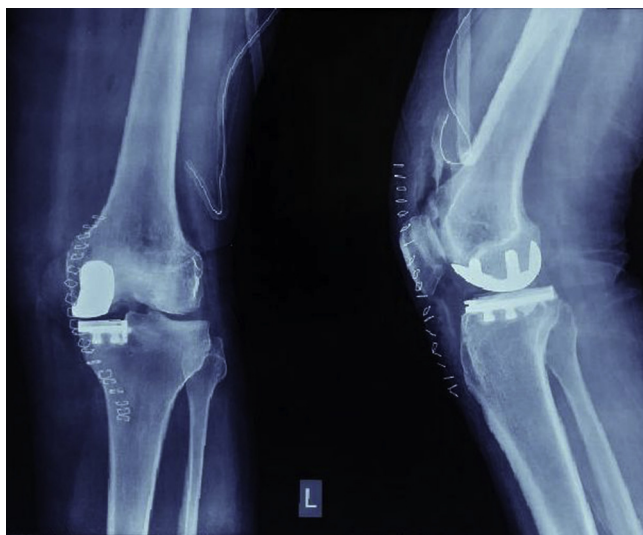
Figure 1. Immediate postoperative radiographs following index medial compartmental arthroplasty surgery showing well-fixed and well-aligned femoral and tibial components.

Two years prior to this, he had presented with primary degenerative osteoarthritis involving both knees with a Knee Society Score (clinical, KSS) and Oxford Knee Score (OKS) of 72 and 35 (left knee) and 64 and 28 respectively (right knee) with predominant medial compartment involvement on the left knee. The overall University of California, Los Angeles (UCLA) activity score was 3. A medial UKA was performed on the ipsilateral (left) knee and a TKA was done for the right knee. The immediate postoperative radiographs of the left knee showed a well-fixed unicondylar implant in slight varus alignment with no evidence of retained cement or debris (Fig. 1).

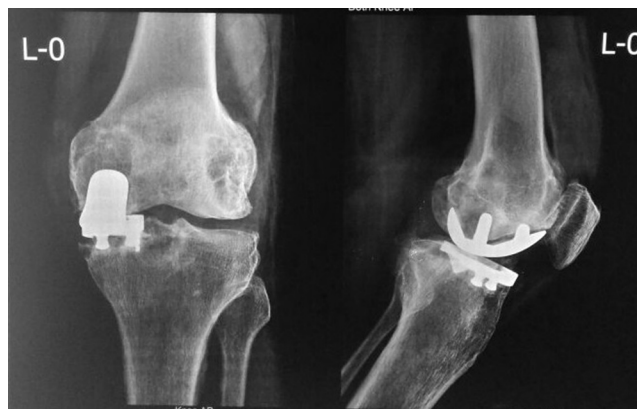
Knee radiographs revealed particulate densities behind the posterior femoral condyles. The medial joint space was completely diminished and the femoral component was in contact with the

Figure 2. At 2 years of follow-up, anteroposterior and lateral radiographs of medial UKA knee showing posterior displacement of femur, absent medial joint space, and increased femorotibial contact area.

posterior aspect of the metal backed tibial component (Fig. 2). Radiolucent lines and cystic changes were seen underneath the metallic tibial tray and also surrounding the 2 tibial studs with evidence of loosening of the femoral and tibial components.

A blackish tinged synovial fluid was aspirated with a white blood cell count of $5400/\text{mm}^3$ and 35% neutrophils. Leucocyte esterase was not detected and 2 days of culture did not reveal any organism. The erythrocyte sedimentation rate was 7 and C-reactive protein $<0.6 \text{ g/dL}$. A diagnosis of aseptic loosening of the implant with metallosis was made and a revision to a TKA was planned.

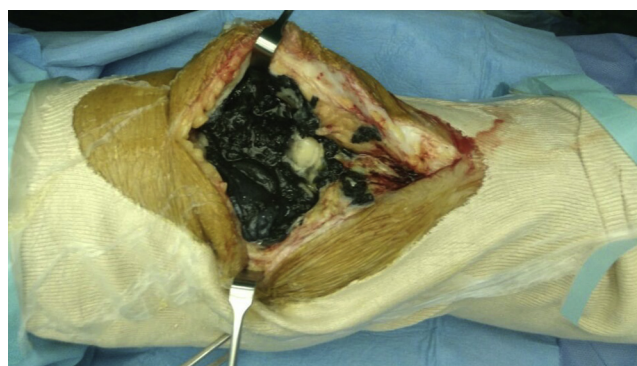
Intraoperatively, extensive blackish staining of the synovium, capsule, and the surrounding tissue was noted (Fig. 3). The synovium was rubbery in consistency and blackish staining of the synovial fluid was noted. Complete synovectomy was performed along with debridement of the surrounding tissue to debulk the metallic debris without compromising the integrity of the collateral ligaments. The ACL was found to be deficient which may have occurred due to an attritional rupture since there was no significant history of trauma or fall. There was full thickness wear of the posterior one-third and posteromedial aspect of the polyethylene component and the tibial tray (Fig. 4). The femoral component was loose but the anterior half of the tibial tray was well fixed. There was evidence of osteolysis underneath the femoral component and posterior aspect of tibial component with subsidence of the metallic tibial tray.

Figure 3. Intraoperative image showing black rubbery synovium due to massive metallosis.
