Transient and Regional Ischemia Related to Continuous Saline Solution Infusion during Radial Artery Access

ABSTRACT

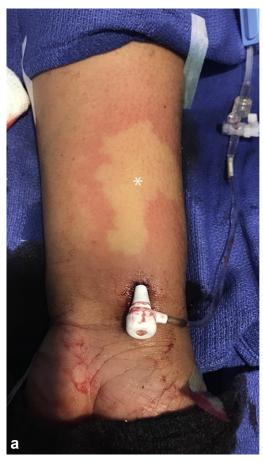
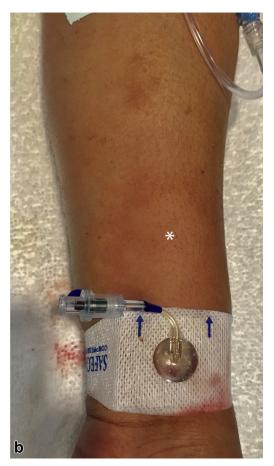
Figure 1. Left volar forearm of a 48-year-old woman following radial artery catheterization for UAE. (a) Blanched skin lesion (asterisk) at the time of completion of the procedure. (b) Resolution of the lesion (asterisk) at 24 hours after the procedure.

After hemostasis was achieved and the sheath was removed, physical examination of the wrist revealed a single well-circumscribed, nontender, nonfluctuant 2.0-cm \times 3.0-cm elevated area with a geographic erythematous border and a pale center on the volar aspect of the forearm just proximal to the left radial artery access site (**Fig 1a**). The radial and ulnar pulses were intact. The remainder of the physical examination findings were unremarkable. At the time of discharge, nearly 24 hours after the procedure, the lesion at the access site had largely resolved, with the degree and area of blanching greatly reduced (**Fig 1b**).
