## AAHKS Symposium

## Diagnosis Taper Corrosion: When Is It the Taper and When Is It Something Else?

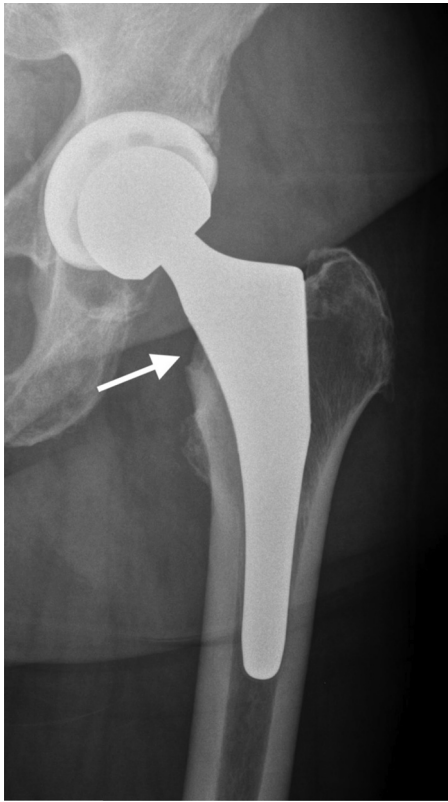
**Fig. 1.** Anteroposterior view of the left hip showing an osteolytic lesion at the base of the calcar in a patient with ALTR due to taper corrosion.

A careful review of the patient's plain radiographs is critical for identifying the cause of pain. As previously discussed, the physician must rule out implant loosening or failed ingrowth of cementless components by either identifying signs of osseointegration that rule loosening out or identifying signs of loosening such as progressive migration. Once loosening has been ruled out, subtle radiographic findings may suggest an adverse local tissue reaction. While at first glance the radiographs may appear negative, we occasionally do see osteolytic lesions, typically in the calcar area (Fig. 1). In other cases, dramatic radiographic abnormalities are seen (Fig. 2).

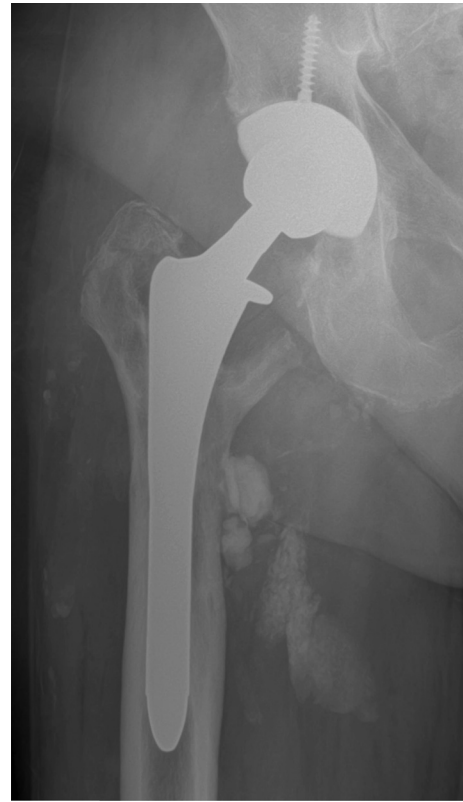
**Fig. 2.** Anteroposterior view of the right hip showing extensive proximal femoral osteolysis with calcific debris in the setting of ALTR due to taper corrosion.
