Case study

Failure analysis of a diesel generator connecting rod

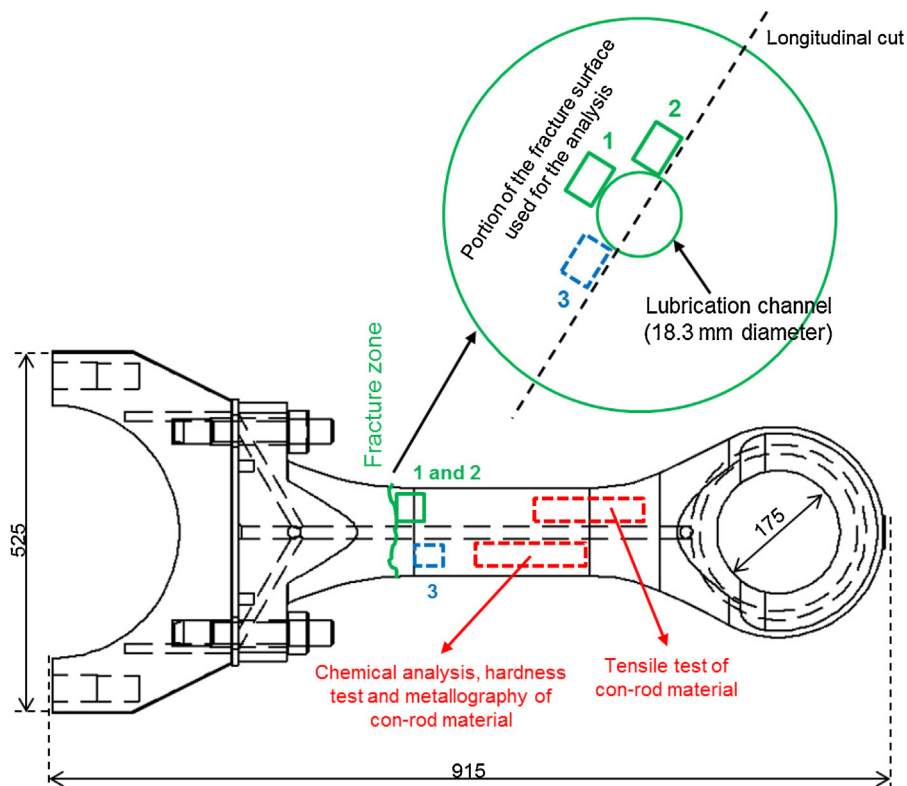
Then, a comprehensive characterization of the con-rod material was conducted; samples were removed from a zone away from the fracture zone (Fig. 2 shows the location of samples for the tests, as well as the dimensions of the con-rod) in order to carry out the following tests: chemical analysis, hardness test, metallographic analysis, and tensile test. Chemical analysis was conducted with a Bruker Magellan Q8 atomic emission spectrometer, according to ASTM E415-14 [10]. Tensile tests were conducted in longitudinal samples (2) located at the mid radio of the body of the con-rod, tests were conducted according to ASTM A370-15 standard [11] using a Zwick Roell Z250 tensile test machine. Hardness testing was conducted according to ASTM E384-11e1 standard [9] employing a Zwick Roell ZHV30 hardness tester (9 indentations). Samples for metallographic analysis were prepared according to ASTM E3-11 [12] and ASTM E407-07(2015)e1 [13] standards, they were mounted in epoxy resin and subjected to a grinding and polishing processes with sand paper and diamond paste, respectively. Samples microstructure was revealed after chemical etching with a 2% Nital solution; the analysis was carried out with a Leica M2 optical microscope, equipped with a digital camera.

Fig. 2. Location of samples for the analysis of the con-rod material and the fracture zone.
