Fractographic ceramic failure analysis using the replica technique

Susanne S. Scherrer^{a,*}, Janet B. Quinn^b, George D. Quinn^c, H.W. Anselm Wiskott^a

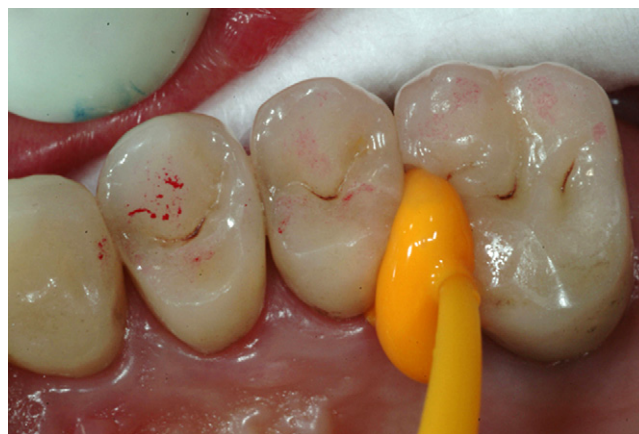
Fig. 2 – After having cleaned the fractured surface with an alcohol cotton pellet and air-dried, the silicone impression material is injected first on the fractured zone.
