Thaumasite formation in a tunnel of Bapanxia Dam in Western China

Abstract

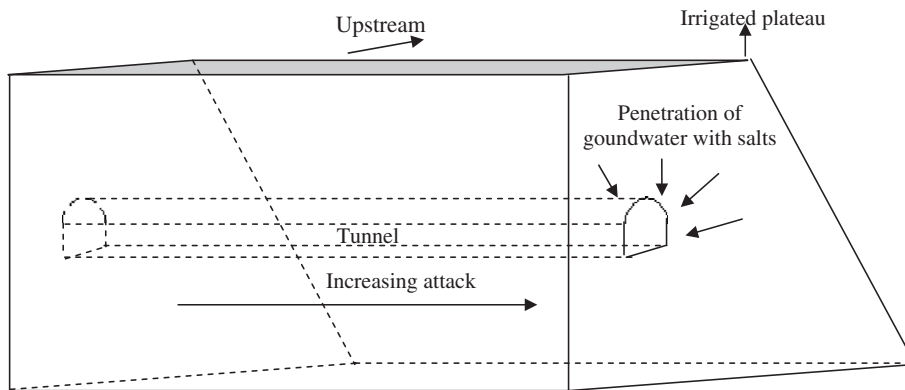
Fig. 1. Schematic diagram showing the concrete dam layout.

Fig. 1 shows the general layout of the dam, looking upstream. The irrigated plateau is situated on the north bank of the dam along the river, where the soil and the groundwater contain a high concentration of sulfate. Observations within the tunnel suggest that the run-off water, which is rich in sulfate, percolates from the outer surface through cracks and preformed ducts to reach the tunnel, where it collects in the drainage channel. At the points of entry, the tunnel wall concrete is also seriously attacked, particularly at the northern end which is closer to the irrigated plateau. In some areas, deep deposits of white crystalline salts were also seen deposited on the tunnel walls, confirming the flow of mineralized water through the concrete into the tunnel.
