Numerical investigation of the failure of a building in Shanghai, China

Jinchun Chai^a, Shuilong Shen^{b,*}, Wenqi Ding^c, Hehua Zhu^c, John Carter^d

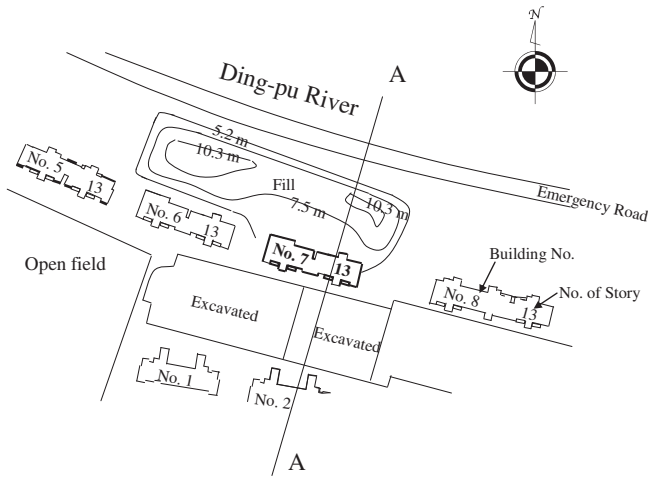
Fig. 1. Plan view of the development area and the location of the building failure (modified from Zhu et al. [18]).

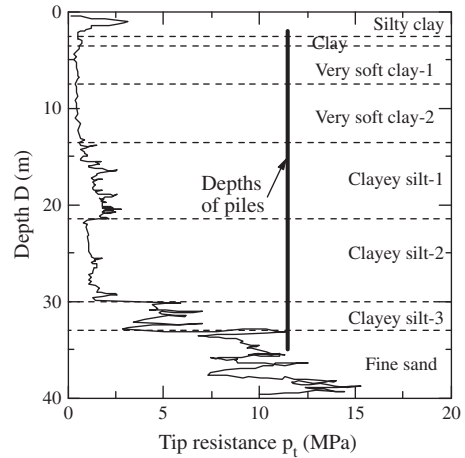
Yin and Xu [15] reported a typical profile of the tip resistance in a cone penetration test (CPT) carried out at the site of Building No. 7, as shown in Fig. 3. Down to the sand used as a bearing layer for

Fig. 3. Cone penetration tip resistance.
