# A rehabilitation study of sandwich GRC facade panels

João R. Correia <sup>\*</sup>, João Ferreira <sup>1</sup>, Fernando A. Branco <sup>2</sup>

Glass fibre-reinforced concrete (GRC) has been used for more than 30 years in the construction industry, especially in facade panels. In this paper, a rehabilitation case study is presented, of a building where cracking and excessive deformations were detected in the sandwich GRC facade panels due to thermal effects. The structural behaviour of the panels was simulated with a finite element method (FEM) model, validated by experimental tests performed on the facade, and then used to assess the efficiency of a repair technique, based on external insulation, which showed a good efficiency.

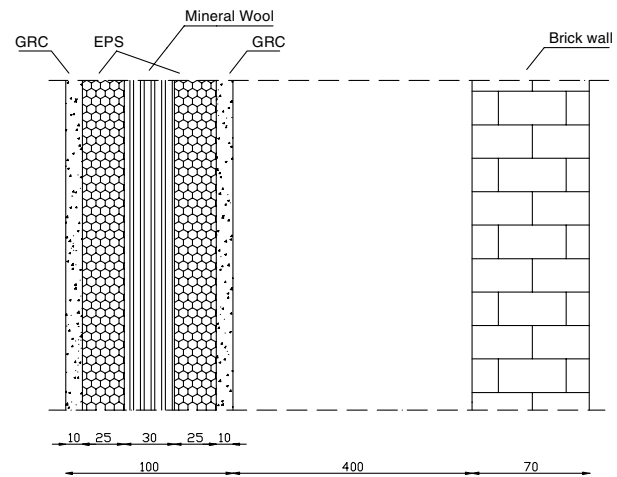
Fig. 2. Facade section (dimensions in mm).

The facade elements are 2.80 m wide and 3.25 m high sandwich panels (Fig. 1), with two external 10 mm thick GRC sheets, outside two 25 mm thick expanded polystyrene (EPS) sheets and a 30 mm thick mineral wool sheet in the middle (Fig. 2). The two external GRC sheets are connected by two vertical and two horizontal 10 mm thick interconnecting GRC laminas to provide global geometrical stability. The panels are supported at the bottom on the floor slabs with an identical 300 mm wide horizontal sandwich element. The facade panels have two vertical sandwich elements which are aligned with the vertical extremities of the window central opening and provide global stability of the facade. The facade panels are connected to the building pavement slabs (on the top and on the bottom) by means of bolted steel angles (Fig. 1).

The facade panels are 0.40 m distant from an interior 0.07 m thick brick wall (Fig. 2) next to the interior of the
