Case Studies in Engineering Failure Analysis

Effect of additional holes on transient thermal fatigue life of gas turbine casing

Keywords: Gas turbine casing Additional holes Transient thermal fatigue crack propagation life Residual stress

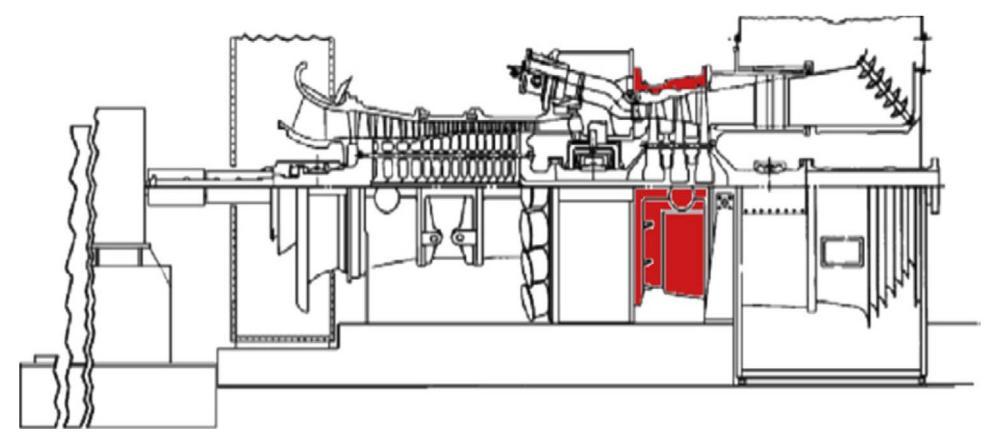
Fig. 1. Side-section view of gas turbine.

Fig. 1 shows the turbine casing (red) and a side-section view of a gas turbine. The casing consists of two half-casings made of ductile cast iron and connected by flanges. Fig. 2 is a 3D drawing of the casing showing the position of the eccentric pin hole. The position of the crack on the casing surface was investigated using non-destructive tests. Fig. 3 shows a sample crack determined by penetrant testing. Table 1 lists the results of chemical analysis of the casing material and indicates good correlation with ASTM-A395 ductile cast iron. Table 2 lists the mechanical properties of ASTM-A395 ductile cast iron.
