# Fractures of a Single Design of Highly Cross-Linked Polyethylene Acetabular Liners: An Analysis of Voluntary Reports to the United States Food and Drug Administration

Michael P. Ast, MD, Thomas K. John, MD, Anthony Labbisiere, Nicolas Robador, MD, Alejandro Gonzalez Della Valle, MD

Department of Orthopaedic Surgery, Division of Adult Reconstruction and Joint Replacement Surgery, Hospital for Special Surgery, New York, New York

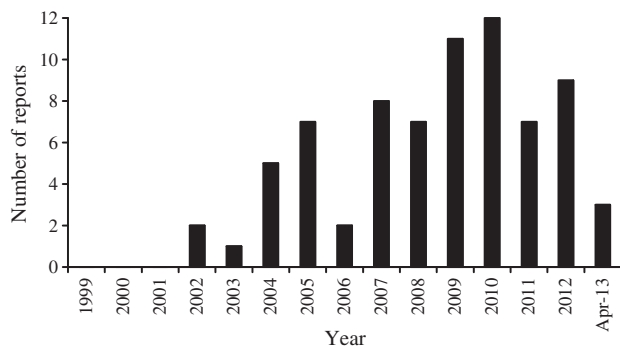
**Fig. 1.** Histogram demonstrating the increasing number of reports of fractured or broken Longevity HXLPE liners per year to the US FDA.

The number of reports of broken or fractured Longevity liners has increased since the introduction of Longevity to clinical practice in 1999 (Fig. 1). The average time in situ was 27 months (range: 1 to 96). The polyethylene thickness in the weight-bearing portion of the liner was  $\leq 6$  mm in 59 of 72 cases and  $\leq 7$  mm in 68 of 72 cases. Similarly, the polyethylene thickness at the rim, which is the area that fractured in the majority of the cases was  $\leq 3.7$  mm in 61 of 72 cases and  $\leq 4.7$  mm in 70 of 72 cases (Table 1). In an analysis of 44 reports in which polyethylene thickness in the weight-bearing area and at the rim, and time in situ of the implant were available, no correlation was detected between the material thickness and the time in situ ( $r = -0.17$ ) (Fig. 2).

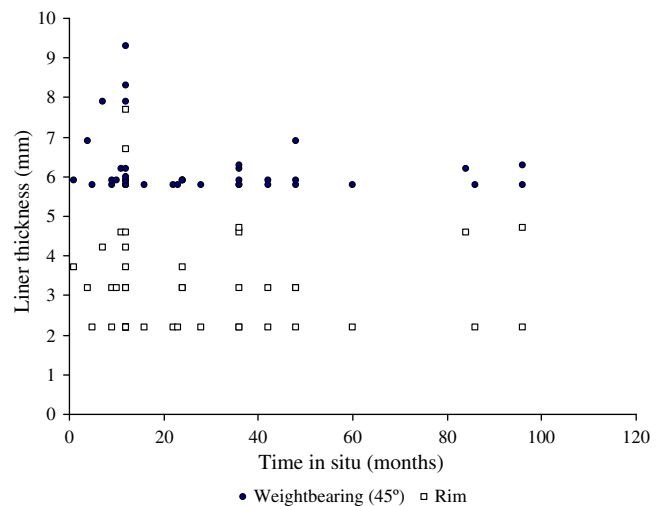
**Fig. 2.** Plot chart demonstrating the time in situ and polyethylene thickness in 44 broken Longevity liners reported to the FDA ( $r = -0.17$ ).
