Failure analysis on recovering low resistive via in mixed-mode device

M. Castignolles *, J. Goxe, R. Martin

Freescale Semiconducteurs France SAS, Toulouse Product Analysis Laboratory, France

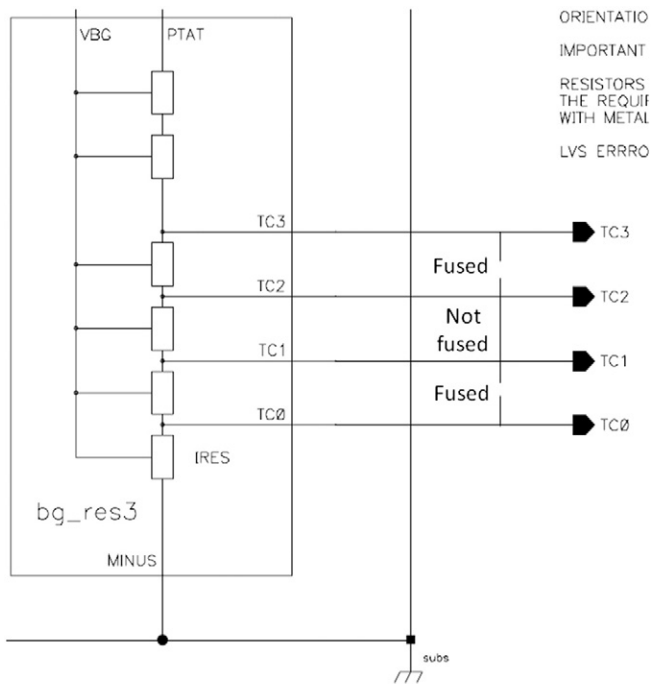
Vreg is directly linked to BandGap voltage so the first step of EFA was to verify this value thanks to micro-probing. It was found higher than normal. Thermal compensation (TC) value can be adjusted by fuse selection of various combinations of resistors to change the 'PTAT' component of the bandgap (Fig. 1). The fuse state can be determined thanks to high magnification optical microscopy. Fuse states appeared to be correct. The next step was to verify this statement by measuring the resistance value. Micro-probing and I(V) characteristics were performed between the different TC pads (TC0, TC1, TC2 and TC3) and ground with a current-clamp at 100 μA . An abnormal high resistance was

Fig. 1. Electrical schematic of the bandgap resistor bridge.

found between TC3 and ground (+2.5 k Ω). Further measurements showed that this extra resistance was located between TC3 and TC2. After those measurements, the failure recovered and Vreg were measured within specification. At this time, it was not known if mechanical constraint induced by TC pad micro-probing or current injection due to I(V) measurements was responsible of the recovery event.
