# Lessons learned from analyzing a VCE accident at a chemical plant

On June 5, 2017, there was a Vapor Cloud Explosion (VCE) at JinYu Petrochemical Co. Ltd. During unloading of liquefied natural gas, the gas leaked from the truck and formed a vapor cloud, then the vapor cloud met with the electrical sparks in the plant laboratory, and an explosion occurred. This incident caused significant casualties and property loss. The main causes of the accident are demonstrated by a fishbone diagram. The major causes include (a) defective design, (b) noncompliance with standard operation procedures (SOPs), (c) the presence of ignition sources, (d) ineffective enforcement of safety rules, (e) inadequate design of emergency facilities, and (f) delayed emergency response. The analysis reveals that process safety management (PSM) is a crucial factor in the success of chemical plants, especially for small and median-scale companies in developing countries. Dispersion phenomenon of liquefied gas is simulated by commercial Computational Fluid Dynamic (CFD) software. The simulation results approximately agree with the real incident. The simulation indicates that a visual and quantitative consequence

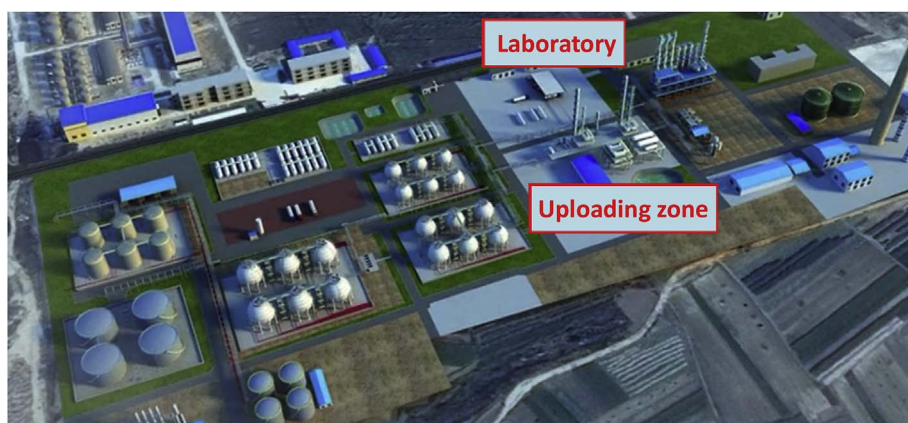
Fig. 1. Plant layout drawing.

The 86,955-square-meter plant had nine 200 m<sup>3</sup> liquefied gas tanks, which stored propane, isobutane and pentane oil, six 1000 m<sup>3</sup> and six 2000 m<sup>3</sup> liquefied petroleum gas spherical tanks, eighteen 150 m<sup>3</sup> pentane oil tanks, six 3000 m<sup>3</sup> liquefied petroleum spherical tanks, six 2000 m<sup>3</sup> isooctane tanks and four 5000 m<sup>3</sup> sulfuric acid storage tanks. On the east side of these tanks, was the loading and unloading area for the tanker trucks. Fifty meters from the north side of the loading/unloading area was the laboratory. The control room and the factory office building were located at the east side of the loading/unloading. The layout of this plant is demonstrated in Fig. 1.
