A failure study of a locking compression plate implant

Nirajan Thapa^a, Michael Prayson^b, Tarun Goswami^{a,b,c,*}^a Department of Biomedical, Industrial and Human Factors Engineering, Wright State University, Dayton, OH 45435, USA^b Orthopaedic Surgery, Sports Medicine and Rehabilitation, Wright State University, Dayton, OH 45435, USA^c Institute of Materials Science and Welding, Graz University of Technology, Kopernikusgasse 24/I, 8010 Graz, Austria

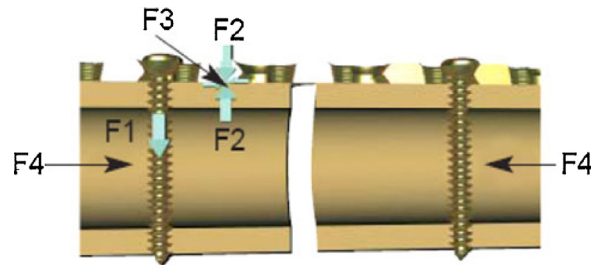
Fig. 1. Mechanics of the locking compression plate technology and forces generated as a result [12] where, F1 = force to tighten the screw into a bone, F2 = reaction force developed because of force F1, F3 = friction force between the plate and bone due to F2, and F4 = axial load [2].
