# Analysis of surface defects of aluminium components with hard anodized layers

Final quality inspection regularly reveals surface defects on components after hard anodizing. The aim of the analysis was to identify the cause of the defects and unambiguously determine whether the defect is caused by the quality of the base material, manufacturing technology of the component, the heat treatment or by the final surface treatment technology (anodizing). Analysis of the chemical composition and hardness measurements were performed to eliminate the possibility of any errors during material selection and heat treatment process. The capillary test revealed two major defects and also small amount of minor defects. To determine cause of the defects, light and scanning electron microscopy including EDS chemical microanalysis was used. Detailed study of the major defect and EDS microanalysis of its interior confirmed existence of defect prior to coating formation. Further examination of the major defect and its surroundings led to conclusion, that the defect was formed during primary foundry processes when billet was manufactured.

A company involved in the manufacture of air systems approach

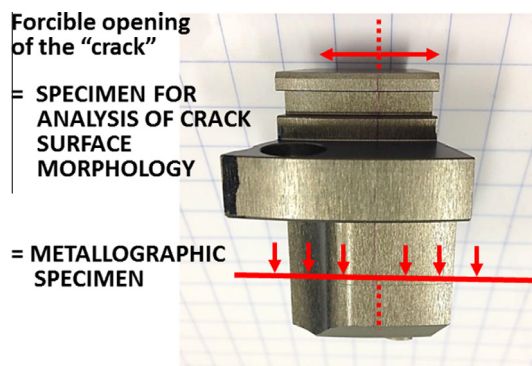
To study the fracture surface, the specimen was prepared by fracturing a segment cut out from the component (see Fig. 2). Detailed analyses of the fracture surface and of the metallographic specimen were carried out on a PHILIPS XL30 scanning electron microscope, which was also used to conduct local surface analyses using the EDAX energy dispersive X-ray analyser.

Fig. 2. Schematic of specimen acquisition for analysing the crack morphology and for metallographic analysis.
