Engineering Failure Analysis

Disaster of an industrial hall caused by an explosion of wood dust and fire

Janusz Krentowski*

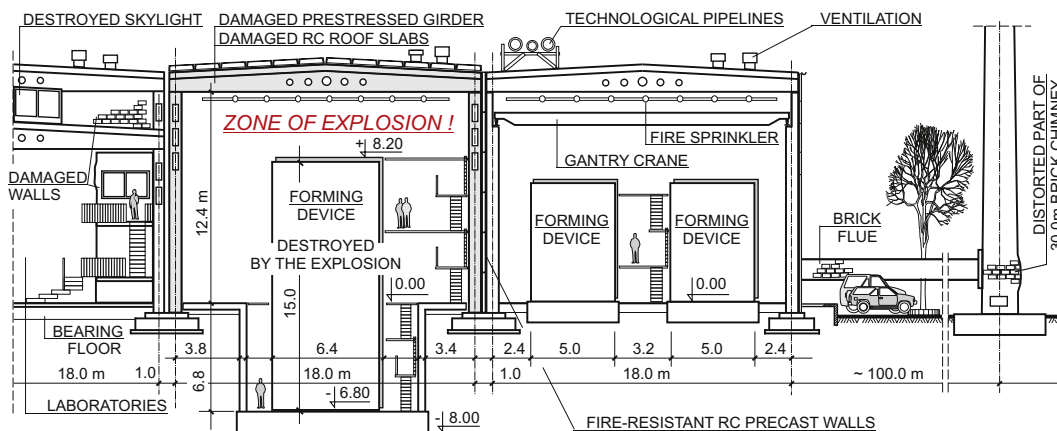
Fig. 2. Cross-section of the industrial halls and the arrangement of the structural elements.

The cross-section of the structural elements of the industrial hall, indicating the location of the equipment and technological installation, is shown in Fig. 2.
