# Failure analysis of submersible pump system collapse caused by assembly bolt crack propagation by stress corrosion cracking

J.A. Escobar\*, A.F. Romero, J. Lobo-Guerrero

Department of Mechanical Engineering, Group of Materials and Manufacturing (CIPP-CIPEM), Universidad de Los Andes (UNIANDES), Cra 1 No. 18A-12, Bogota, Colombia

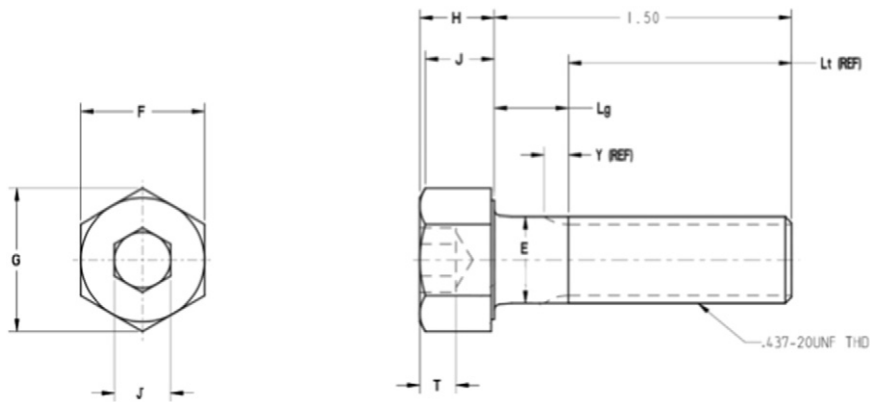
Fig. 1. Dimensions of the bolt based on ANSI B18.2.1.

Two casing assembly bolts (Hex Head Socket Cap Screw .437-20UNF X 1.50) were received; the first one was fractured near the head, while the second one was in good condition. The material specified by the manufacturer is Monel K-500 and the dimension of the bolt follows ANSI B18.2.1 specifications as shown in Fig. 1. The function of these bolts was to connect the casings of two 390HP motors used in a submersible pump as shown in Fig. 2a.
