Premature failure analysis of forged cold back-up roll in a continuous tandem mill

In this paper, premature failure of a forged back-up roll from a continuous tandem mill was investigated. Microstructural evolutions of the spalled specimen and surface of the roll were characterized by optical microscopy, X-ray diffraction, scanning electron microscopy and ferritscopy, while hardness value of the specimen was measured by Vickers hardness testing. The results revealed that the presence of pore and MnS inclusion with spherical and oval morphologies were the main contributing factors responsible for the poor life of the back-up roll. In addition, metal pick up and subsequently strip welding on the surface of the work roll were found as the major causes of failure in work roll which led to spalling occurrence in the back-up roll. Furthermore, relatively high percentage of retained austenite, say 9%, in outer surface of the back-up roll contributed spalling due to conversion of this meta-stable phase to martensite and creation of volume expansion on the outer surface through work hardening during mill campaign.

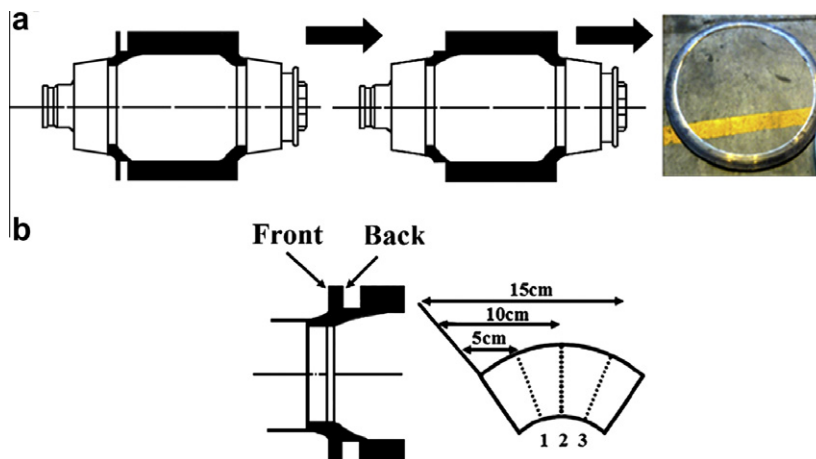
microstructural and fractographic examinations. To prevent converting back-up roll being scraped and any phase transformation during cutting as well as to obtain reliable results several methods were investigated for sampling; consequently a ring (Fig. 1a) measuring 1365 mm in diameter, 15 mm in thickness and 100 mm in depth was carefully removed during 24 h from a tandem mill back-up roll by heavy duty lathe machine (INNSE 62"). Several samples (Fig. 1b) were then cut from the ring for further microstructural and microhardness experiments.

Fig. 1. (a) The ring cut from the tandem mill back-up cold roll and (b) samples cut from the sector of the ring.
