## Dendrochronologia

# Natural hazards and building history: Roof structures of Segovia cathedral (Spain) reveal its history through tree-ring research

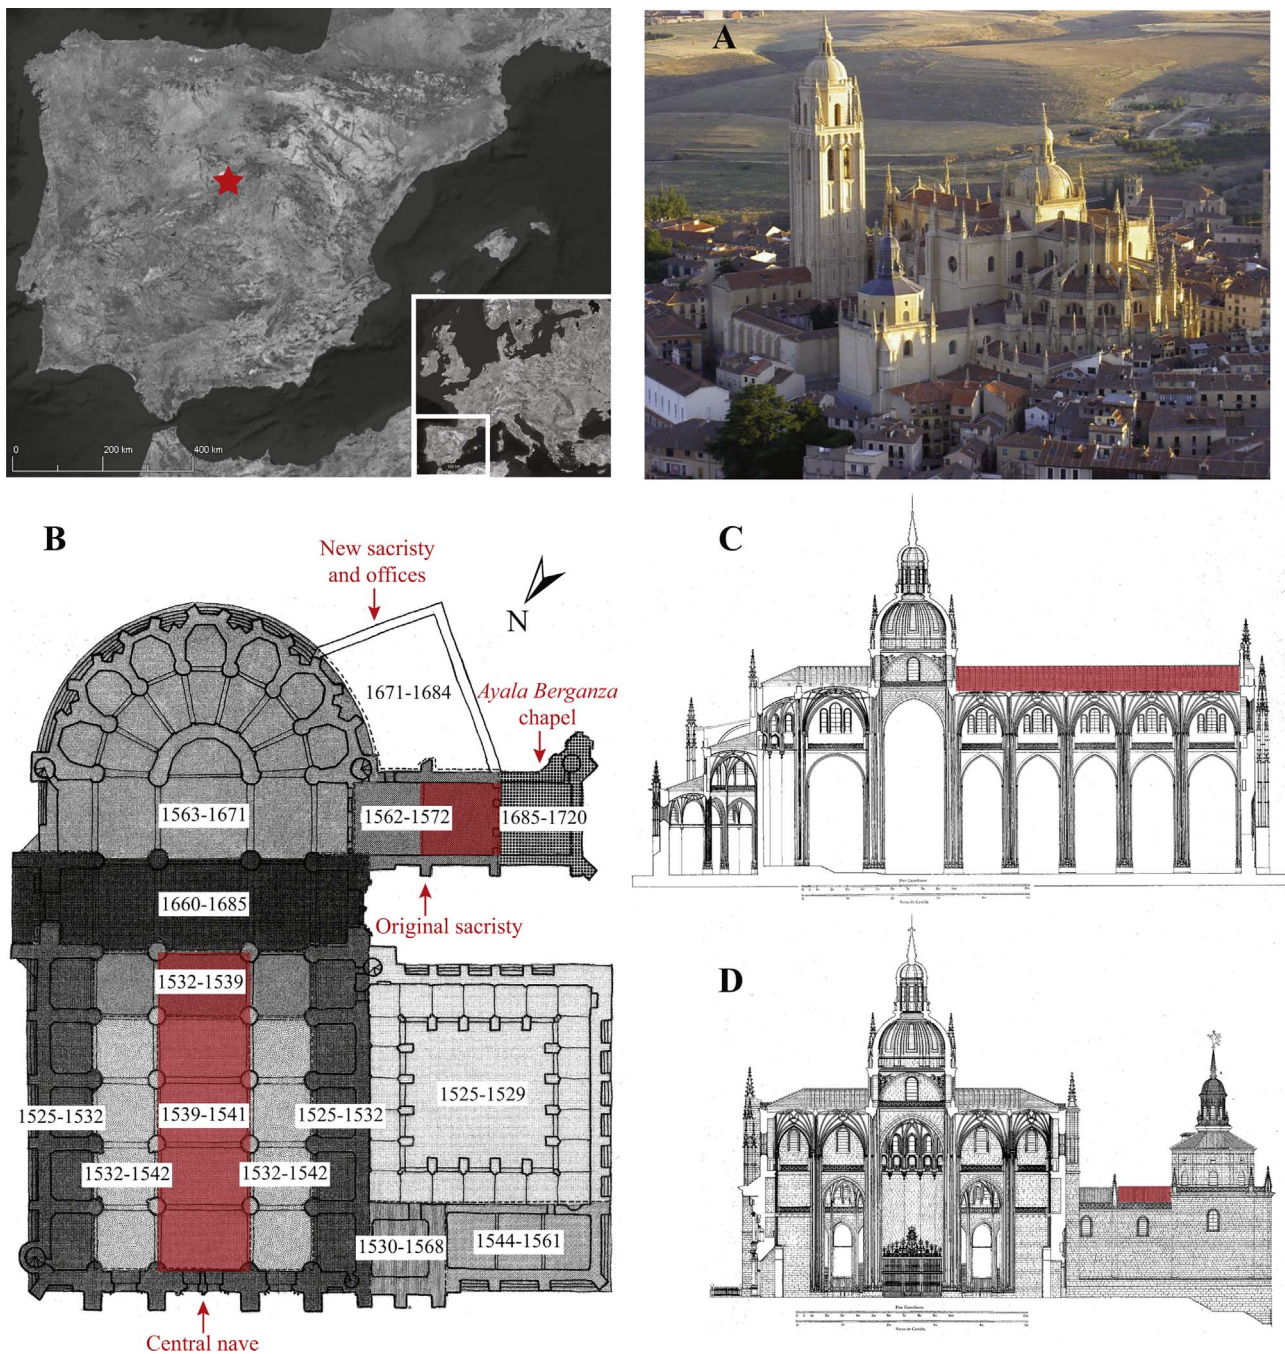
**Fig. 1.** Location map and different views from Segovia cathedral: A) aerial view courtesy of the Cabildo catedralicio; B) floor plan by A.M. Belouqui indicating construction periods and relevant parts of the building mentioned in the text (adapted from Cortón de las Heras, 1997); C, D) Longitudinal and transversal sections respectively representing the current cathedral building (courtesy of architect J.M. Merino de Cáceres). The red-shaded areas indicate the researched roof structures (nave and western part of the original sacristy).

Romanesque building during the Revolt of the *Comuneros* in 1520, the construction of the new cathedral began in 1525 at its current location, the highest point in the centre of the old town (Fig. 1A). The body of the naves was completed towards 1542, and the rest of the first phase of construction, including the bell tower, in 1557 (Cortón de las Heras, 1997). Other two construction phases followed, the second one from 1558 to 1607, which among other works involved the first sacristy between 1562 and 1572 (Ruiz Hernando, 2003); and the third and final phase from 1607 to 1685, which encompassed the construction of a new sacristy and the offices on the south-western part of the building (Cortón de las Heras, 1997). An additional modification was carried out between 1685 and 1720, when the *Ayala Berganza* chapel, topped by a dome, was added to the western side of the old sacristy (Fig. 1B). This

last addition conferred the cathedral its present-day structure (Figs. 1C,D).
