Effect of a hydrogenated interface on the wear behavior of a diamond-like carbon film in a water environment

Hydrogenated diamond-like carbon (DLC) films or DLC films with hydrogenated interlayers tend to undergo early stage failure in water environments for reasons that are not fully understood. In this paper, a hydrogenated interface was prepared between a hydrogen free DLC film and a CoCrMo substrate, and the effects of the hydrogenated interface on the film structure, hardness, adhesion, wear behavior and corrosion resistance were investigated. The hydrogen free DLC films on the hydrogenated and the hydrogen free substrates exhibited similar structures and mechanical properties. The DLC films on both the hydrogenated and the virgin CoCrMo substrates exhibited good adhesion. The adhesions of the DLC films on both the substrates were not deteriorated after 150 days of immersion in 0.9% NaCl solution. The wear resistance of the DLC film on the hydrogenated CoCrMo substrate was worse than that on the virgin CoCrMo substrate in water. The presence of hydrogen improved the activity of the interface, restrained the formation of a passivation layer, and promoted the corrosion of the i

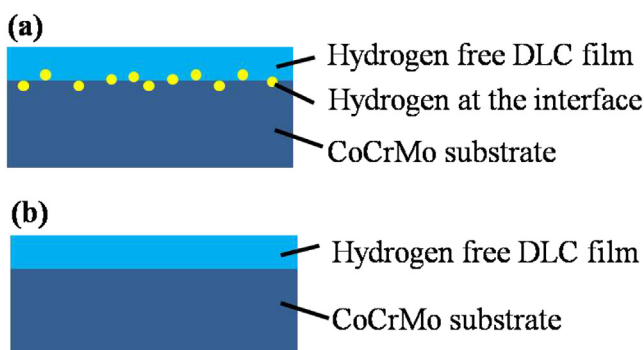
Fig. 1. Schematic diagrams of (a) CoCrMo/H/DLC and (b) CoCrMo/DLC.

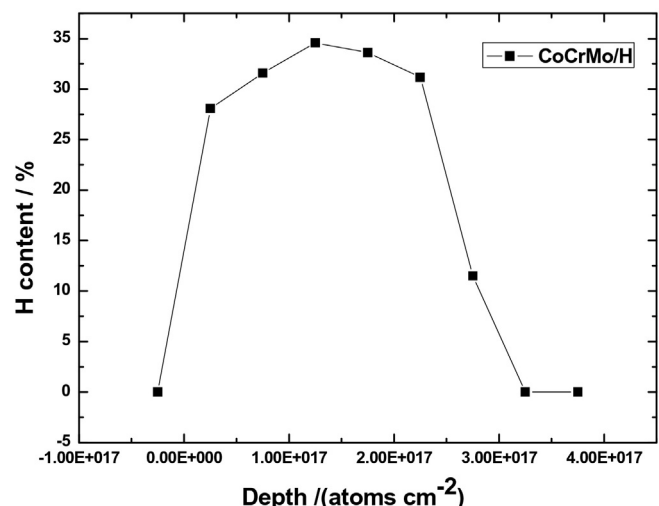
Fig. 2. Variation in the hydrogen content along the depth in CoCrMo/H.

The hydrogen content at the CoCrMo/H surface was detected in the depth direction by ERDA. As shown in Fig. 2, the maximum hydrogen content at the CoCrMo/H surface is \sim 35%, confirming that a hydrogenated surface was successfully prepared on the CoCrMo substrate. The structures of the CoCrMo/DLC and the CoCrMo/H/DLC samples were characterized by Raman spectroscopy, as shown in Fig. 3. The Raman spectrum of CoCrMo/DLC was similar to that of CoCrMo/H/DLC. The Raman curve can be fitted using the Gaussian function to yield D and G peaks; the I_D/I_G value is related to the number and the size of sp² clusters. The I_D/I_G value of CoCrMo/DLC was similar to that of CoCrMo/H/DLC, indicating that the structure of CoCrMo/DLC is similar to that of
