## A survey of flaws near welds detected by side angle ultrasound examination of anhydrous ammonia nurse tanks

A sample of 532 anhydrous ammonia nurse tanks with manufacture dates ranging from the 1950's to 2011 were examined during 2012 by side angle ultrasound to measure the locations, sizes, and orientations of flaw indications. The indications were most frequently located on the head side of the head-to-shell welds and oriented perpendicular to the weld line in the welds' heat affected zones. On average newer tanks had more indications than older tanks. Tanks that had been given a post-weld stress relief anneal had markedly fewer indications.

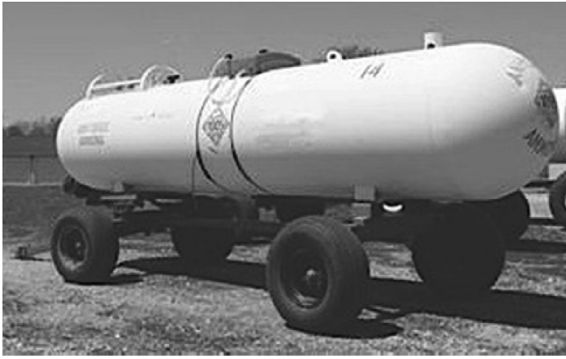
Fig. 1. Anhydrous ammonia nurse tank mounted on running gear. (Photo courtesy of the Federal Motor Carrier Safety Administration.)

Anhydrous ammonia (NH<sub>3</sub>) is a toxic chemical used as an agricultural fertilizer distributed to farm fields via nurse tanks (Fig. 1), which hold NH<sub>3</sub> in liquid form under pressure. The steels used to manufacture nurse tanks are all low-carbon, low-alloy steels with mixed ferrite-pearlite microstructures (e.g., ASTM A285, ASTM A455, and ASTM A516 grade 70). The Fertilizer Institute estimates that about 200,000 nurse tanks are in use in the United States; many are between 20 and 50 years old.

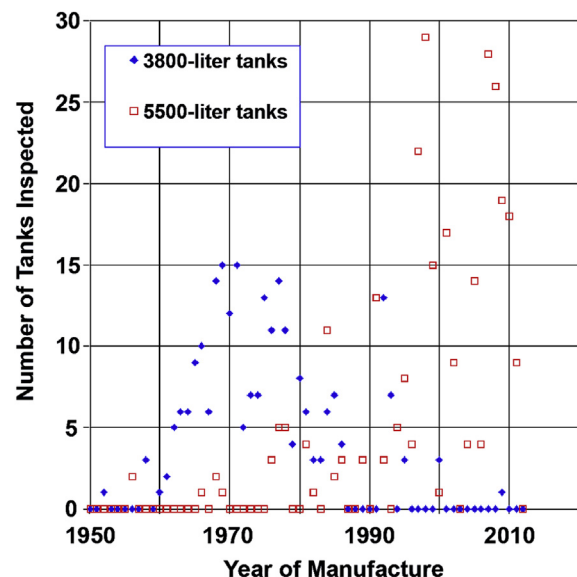
Fig. 2. Scatterplot of the tanks inspected as a function of year of manufacture.
