Investigations of lightning accidents on automobiles

Shunichi Yanagawa^a, Kazuo Yamamoto^{b,*}, Yuta Naito^a, Naoto Takahashi^c,
Michihiro Matsui^d

Lightning
Fire accident
Automobile
Statistical data
LLS

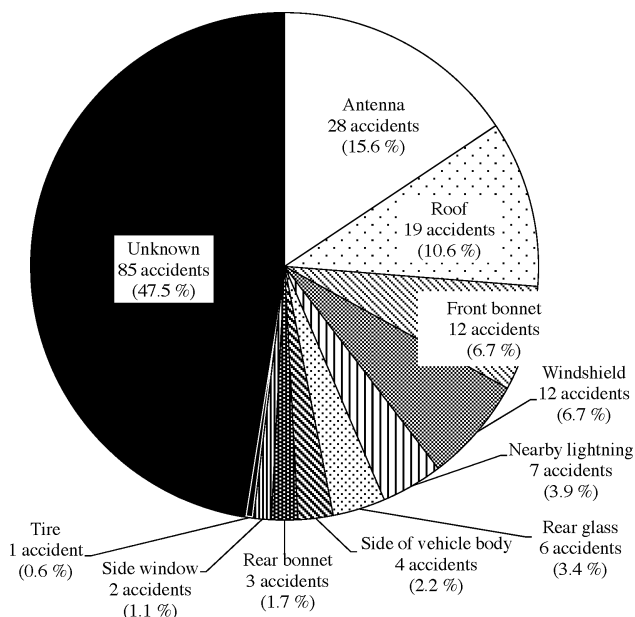
Fig. 1. Trends of lightning attachment points.

Trends of lightning attachment points are shown in Table 1 and Fig. 1. In 88 cases out of 173 (50.9%) of lightning accidents, the lightning attachment point was identified. Antenna was the most likely lightning target, followed by roof, front bonnet and windshield. Damages to the upper body such as the antenna, roof, front bonnet and windshield are easily understood because lightning stroke to them is very probably. Especially, the antenna is often attached to the highest point of the vehicle; thus, the possibility of lightning stroke to the antenna is higher than at other surrounding parts. The height of antenna affixed to modern vehicles often approximates the roof height. The relationship between antenna height and lightning attachment point is a future consideration. Incidentally, the data of Table 1 and Fig. 1 sum to 179, the number is larger than that of the reported accidents (173). This anomaly arises from a single of triple-strike and four times of double-strike lightning accidents involved.

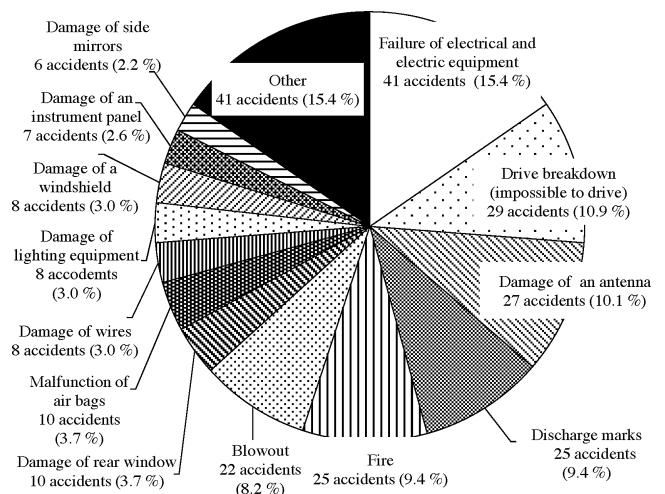
Fig. 2. Trends of damages due to lightning.

Table 2 and Fig. 2 categorizes the different types of automobile damages caused by lightning strokes. The specific damage could be identified in 95 cases out of 173 (56.1%). In Table 2 and Fig. 2, “Drive breakdown” category implies that the vehicle could not drive due to engine failure or similar; “Failure of a battery” category implies that driving capability was restored by the battery replacement during vehicle repair. The sum of the damaged cases in Fig. 2 is 267, the
