Corrosion Science

Stress corrosion cracking at low loads: Surface slip and crystallographic analysis

Stress corrosion cracking (SCC) of 316L single crystal was studied by scanning electron microscopy and electron backscatter diffraction. SCC could initiate and propagate without surface slip at the normal stress of 20 MPa. The cracks grew on the {1 0 0} planes. Many microvoids appeared at the slip bands and microsteps were present on the fracture surfaces. Consequently, the synergistic effects of microcleavage and local dissolution induced SCC advance on {1 0 0} crystal planes. Microshear was an additional SCC microscopic mechanism at high stress levels.

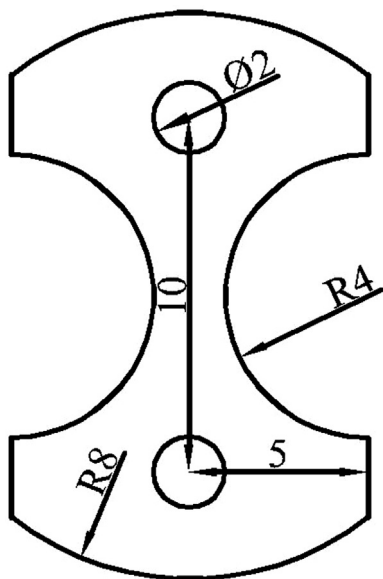
Fig. 1. Schematics of 316L stainless steel single crystal specimens (dimensions are in mm).

316L SS single crystals were used in this study with the following chemical composition: 0.007 wt.% C, 17.00 wt.% Cr, 13.49 wt.% Ni, 2.54 wt.% Mo, 0.66 wt.% Mn, 0.46 wt.% Si, 0.008 wt.% P, 0.0056 wt.% S and Fe balance. The crystals were produced along the $[001]$ direction and machined into 0.7 mm thick specimens with circle holes 2 mm in diameter, as shown schematically in Fig. 1. Prior to experiments, the specimens were annealed at 1050°C for 30 min in argon, water-quenched, ground using 2000 grit emery paper, electrochemically thinned to about 0.5 mm in solution containing H_3PO_4 , H_2SO_4 , CrO_3 , and $\text{C}_2\text{H}_6\text{O}_2$ (glycol), degreased with acetone in an ultrasonic cleaner and washed with deionized water. After the pretreatment, the samples were placed into a glass container filled with a boiling 45 wt.% MgCl_2 solution. Normal stress of either 20 MPa or 40 MPa, calculated in terms of the narrowest section ($2 \times 0.5 \text{ mm}^2$), was applied to the specimens. All experiments were carried out under an open circuit condition using a constant load weight-type apparatus with a cooling system, two 316L SS single crystal pins and two silica grips.

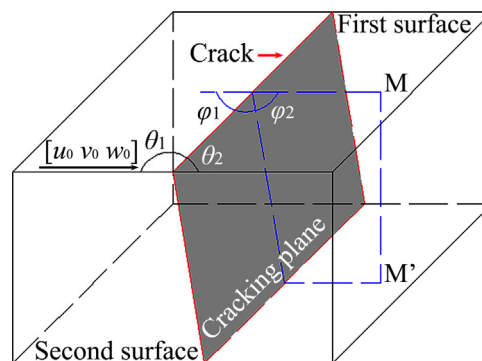
Fig. 2. Schematic diagram of the two-surface trace analysis characterizing the crystallography of the 316L single crystal cracking plane, where M and M' are the labels on the first and second surfaces, respectively. θ_1 and θ_2 are the angles between the crack and the $[u_0 v_0 w_0]$ crystal orientation, while ϕ_1 and ϕ_2 are the angles between the cracking plane and the first surface. The $[u_0 v_0 w_0]$ crystallography of the first surface was determined by electron backscatter diffraction.

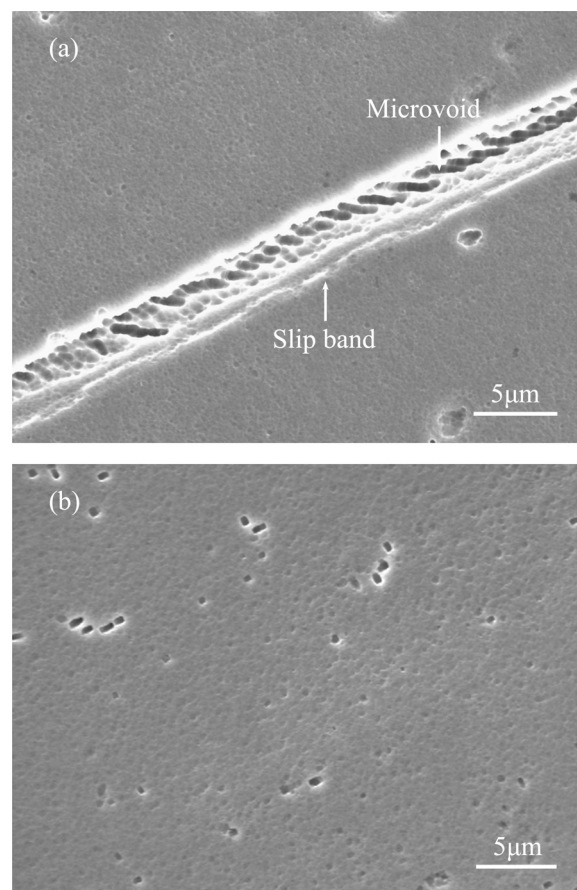
Fig. 3. Surface morphology of the specimens with cleaned off corrosion products, subjected to normal stress of: (a) 40 MPa and (b) 20 MPa. The slip band was corroded and lots of microvoids emerged at the slip band. However, there was no slip band on the surface in Fig. 3(b).

After 200–300 h, SCC cracks grew to a certain size and specimens were taken out from the glass container. Some specimens were ultrasonically cleaned in deionized water as well as 5 wt.% HCl + 2 g/L hexamethylenetetramine mixture to remove corrosion products from the specimen surface. Both cleaned and virgin samples were employed to examine the slip bands and SCC cracks by scanning electron microscopy (SEM). To correlate surface slip and SCC propagation, it was checked whether the slip bands appeared in nucleation areas and near crack tips of short and long cracks. The
