The use of georadar to assess damage to a masonry Bell Tower in Cremona, Italy

Luigia Binda*, Luigi Zanzi, Maurizio Lualdi, Paola Condoleo

DIS-Department of Structural Engineering, Politecnico of Milan, Piazza Leonardo da Vinci 32, 20133 Milan, Italy

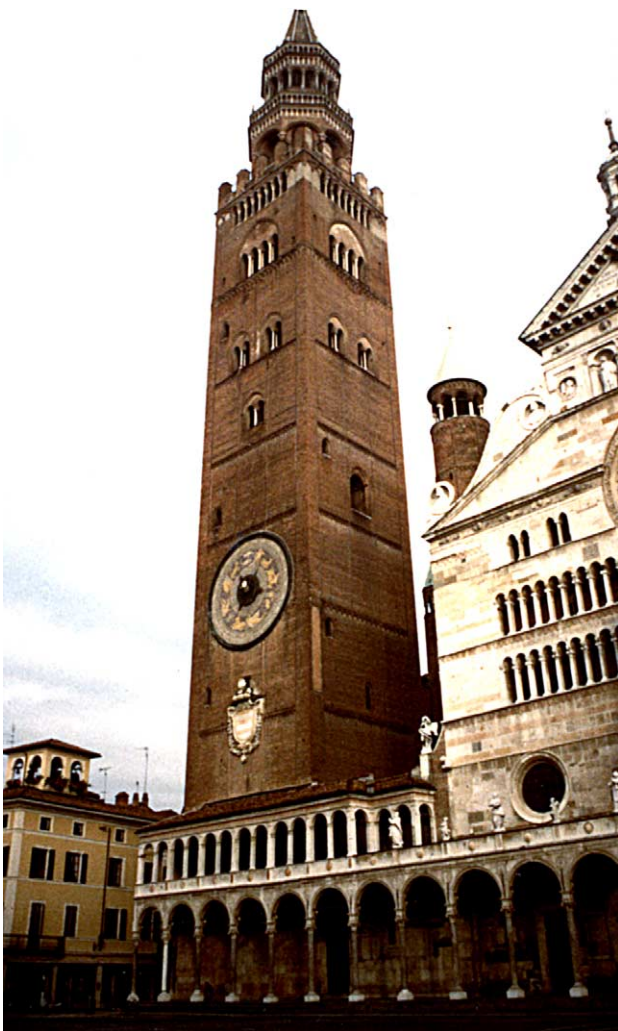
Fig. 1. Picture of the Bell Tower of Cremona (Torrazzo).

The Bell Tower, called ‘Torrazzo’ by the Cremona citizens, is adjacent to the Cathedral (Fig. 1); the date of construction is not well defined and may be either in the 8th or in the 13th century. The tower, probably the tallest Medieval tower in Europe, is 112 m high. Its structure consists of a square plan part up to 70 m and a framed structure called ‘Ghirlandina’ with an octagonal plan and topped by a spire, from 70 to 112 m. The staircase from the ground to the Ghirlandina level was built within
