MISHAP INVESTIGATION BOARD SUMMARY OF EXTRAVEHICULAR ACTIVITY 23: LESSONS LEARNED FROM A SPACEWALK CLOSE CALL

ABSTRACT

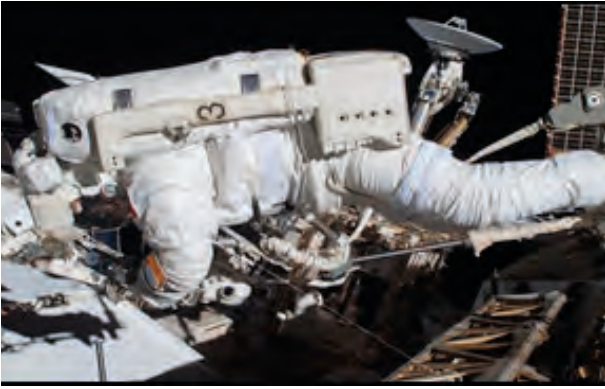
Figure 1. Extravehicular Mobility Unit (EMU)

The current ISS Extravehicular Mobility Unit (EMU) (shown in Fig. 1), a complex spacesuit that provides protection from the extreme conditions of space, is a mobile life support system with an oxygen supply, electrical power, water-cooling equipment, ventilating fan, and an in-suit drink bag. The EMU was originally developed for use on the U.S. Space Shuttle to mitigate failure scenarios in which the Shuttle payload bay doors failed to close and lock properly prior to atmospheric re-entry. An additional postulated failure scenario involved achieving “rescue” of a disabled orbiter by EVA crewmembers entering a depressurized vehicle and accessing the flight deck. This particular risk mitigation approach required that the EVA suit and the Portable Life Support System (PLSS) assembly be sized—width and depth—to pass through the Shuttle hatch openings to the flight deck. The EMU has since evolved from a suit to mitigate Shuttle failure scenarios to one capable of deploying, capturing, and repairing satellites, and enabling astronauts to assemble, repair, and maintain the ISS.
