Marine atmospheric corrosion of Al-Mg joints by friction stir blind riveting

This paper investigated the atmospheric corrosion behavior of Al-Mg friction stir blind riveting joints exposed at a severe marine test environment. Besides the severe corrosion that occurred on Mg alloy AZ31B-H23, Al alloy 5754-O also corroded in the coupled region because of the alkaline condition generated by the cathodic reaction inside of the crevice. The highly alkaline environment, however, passivated Mg deep inside the crevice. The corrosion products on Mg were identified as magnesium carbonates and that on Al was mainly gibbsite, which was an unusual corrosion product of Al exposed to atmospheric conditions.

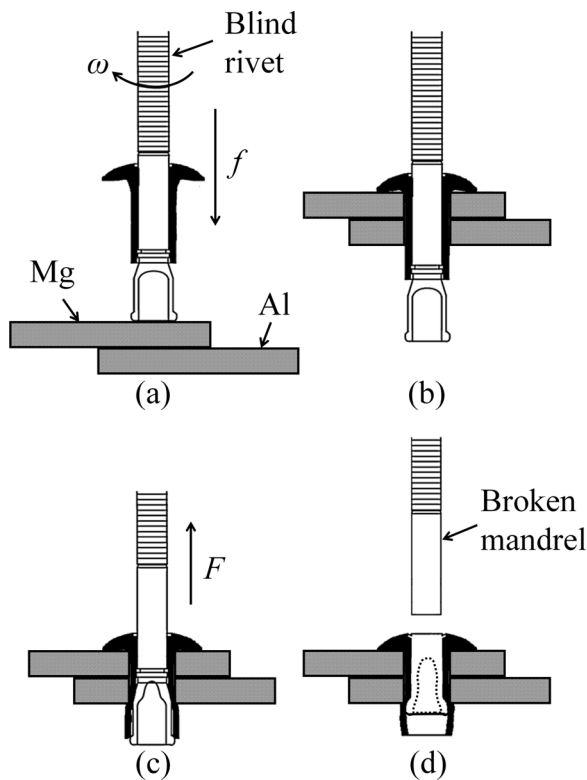
Fig. 1. Illustration of the FSBR process [7]: (a) rotating blind rivet approaching the workpieces; (b) frictional penetration of the rivet; (c) pulling out the mandrel; and (d) completion.

The raw materials used were Mg AZ31B-H23 and Al 5754-O with chemical compositions shown in Table 1. Fig. 1 illustrates the FSBR process for joining the Mg and Al sheets. The Al-Mg FSBR joints were formed on a computer numerical control (CNC) machining center (model: Bridgeport Discovery 308) using 1 mm thick Mg sheets and 3 mm Al sheets. Each work piece was 38 mm wide and 127 mm long. The overlap region had a size of 38 mm × 38 mm. The blind rivet with a diameter of 6.4 mm was made of mild steel with zinc coating. The spindle speed was 5000 rpm and the feed rate was 120 mm/min.
