Rupture pressure of wear degraded alloy 600 steam generator tubings

Seong Sik Hwang ^{*}, Chan Namgung, Man Kyo Jung, Hong Pyo Kim, Joung Soo Kim

Nuclear Material Development Technology Division, Korea Atomic Energy Research Institute, 150 Deokjin-Dong Yuseong-Gu, Daejeon 305-353, Republic of Korea

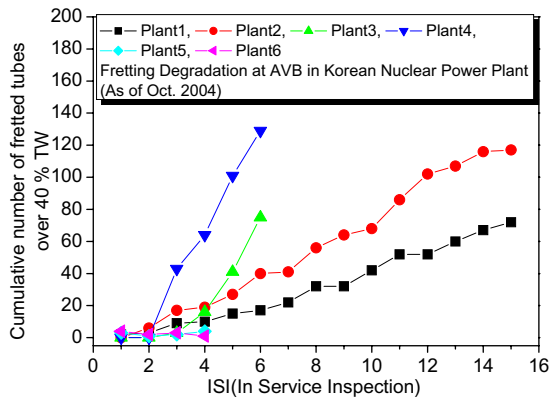
Fig. 1. Degradation trend of a fretting/wear at the AVB in Korean Plants.

SG tubes of a PWR have suffered from various types of corrosion, such as pitting, wastage and stress corrosion cracking (SCC) on both the primary and secondary side of the SG tubes [1,2]. Ligament rupture pressure of axial notch defect machined by an electrodischarge machining (EDM) has been evaluated [3–5]. Wastage was another concern with new steam generator, and it was usually found in the region of a low coolant flow and a high heat flux until the late 1970s [6]. After change of the secondary side water chemistry from a phosphate to an all volatile water treatment (AVT) in the early 1980s, the wastage substantially decreased. Then denting caused by corrosion of carbon steel support and SCC became the main degradation problems of a SG in PWRs. Recently, fretting/wear degradation at the tube support region has been reported in some Korean nuclear power plants as shown in Fig. 1. It is important to establish the repair criteria to assure reac-
