Influence of precipitation behavior on mechanical properties and hydrogen induced cracking during tempering of hot-rolled API steel for tubing

Precipitation behavior and its effect on hydrogen embrittlement during tempering process of hot-rolled API steel designed with 0.4 wt% Cr and 0.25 wt% Mo were investigated. The base steel was normalized and then tempered at 650 °C for up to 60 min. The precipitation behavior of the examined steel was explored using transmission electron microscopy (TEM) analysis, and it was found that the precipitation sequence during tempering at 650 °C were as follows: $MX + M_3C \rightarrow MX \rightarrow MX + M_7C_3 + M_{23}C_6$. The change of particle fraction was measured by electrolytic extraction technique. At the early stage of tempering, the particle fraction greatly decreased due to dissolution of M_3C particle, and increased after 10 min by the precipitation of M_7C_3 and $M_{23}C_6$ particles. The particle fraction showed a peak at 30 min tempering and decreased again due to the dissolution of M_7C_3 particle. Vickers hardness tests of base steel and tempered samples were carried out, and then the hardness was changed by accompanying with the c

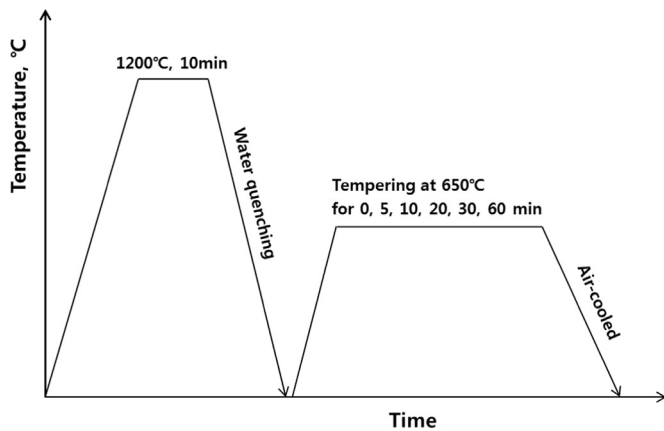
Fig. 1. Schematic illustration for heat treatment of tested alloy.
