The difference between synergistic erosion–corrosion and corrosion of mild steel in SiC suspension

Ming Zhao^{a,*}, Jiadao Wang^a, Darong Chen^a, Xiaopeng Hao^b, Baoyi Wang^b

Abstract

The synergistic erosion–corrosion and corrosion characteristics of mild steel were studied by using rotating disk apparatus and immersing in 0.05 wt.% SiC suspension, respectively. The difference between cavitation erosion and corrosion was determined by scanning electron microscope (SEM), positron annihilation lifetime spectra (PALS) and X-ray photoelectron spectroscopy (XPS). It was found that the propagation of cracks in pit area induced by cavitation erosion did not appear in the course of corrosion. The PALS results showed that the size and number of vacancy cluster induced by cavitation erosion was much larger than that induced by corrosion damage. The results of core level band spectra indicated that there were chemical shifts in the case of cavitation erosion and no chemical shifts except 40 min corrosion in immersion process. The results of valence band spectra implied that the oxidation of mild steel induced by cavitation erosion was more than that induced by corrosion damage.

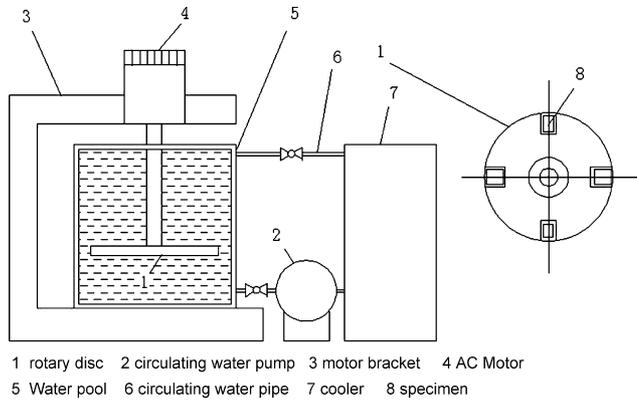
Fig. 1. Schematic diagram of cavitation erosion test apparatus.

The respective cavitation erosion was examined using a rotating disk apparatus as shown Fig. 1, which generates vortex and cloud cavitation and engenders damage in the case of actual hydraulic machinery. The apparatus consists of a stainless steel container, rotating disk, recycle pump and cooling apparatus. Four equispaced samples were installed on the rotating disk. In order to induce the cavitation, an orifice hole was made on the rotating-disk in front of each sample. The rotating speed of the rotating disk was 2400 round/min. As the sample installation site was 5 mm deep, the upper surface of the sample was 1 mm higher than the rotating disk surface. The fluid used in the experiment was 0.05 wt.% SiC suspension and the temperature of the suspension in the experiment was kept at room temperature by a water cooling apparatus.
