Phase transformation studies on the a-C coating under repetitive impacts

The phase transformation of hydrogen-free amorphous carbon (a-C) coating on tungsten high speed steel (SKH2) substrates under repetitive impact testing has been studied. The a-C coated disc was impacted by the chromium molybdenum steel (SCM420) pin at several different impact loads and impact cycles (up to 100,000) under lubricated conditions. The results show that the sp^3 fractions of impacted a-C coating obtained from the surface of impact craters are significantly increased with impact cycles due to decreasing ID/IG ratio. This means that the amorphization of a-C coating also increased after several impact cycles. As for the full-width at half maximum (FWHM) of G peak characterization, it is shown that the hardness of impacted a-C coating is higher than the as-received. From the observation of surface roughness using atomic force microscopy (AFM), it is supposed that increasing sp^3 fractions and the hardness of the impacted a-C coating during impact correlate to the reduction of surface roughness. In addition, the tribochemical reaction to the environment during impact occurred at the mating material, wh

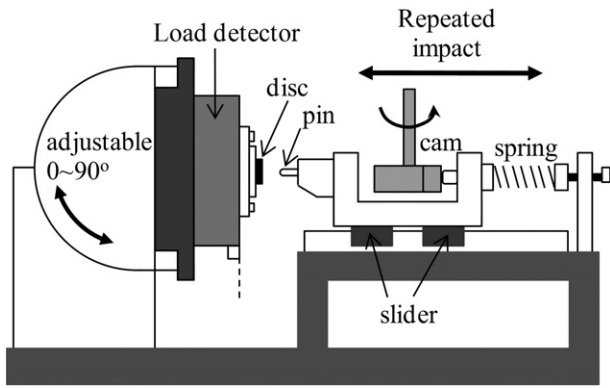
Fig. 1. Schematic illustration of a repeated impact tester.

The impact test rig, as shown in Fig. 1, consisted of a load detector together with a cam that was designed to impact a-C coated disc with a SCM420 pin, with a radius of 1 mm under numerous impacts. The disc was repetitively impacted with a 90° inclination at room temperature. Kerosene was used as a lubricant. Prior to the impact test, both disc and pin were cleaned using acetone in an ultrasonic bath. The load was applied to the disc specimen via a spring system and was observed by the load detector. In this experiment, the frequency of the impacts was selected at 10 Hz. The dimensions of both disc and pin are shown in Fig. 2.

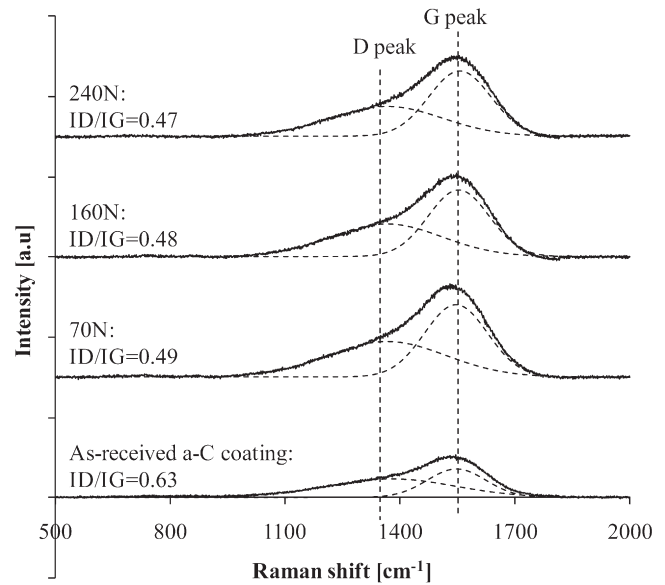
Fig. 3. Raman spectra of the as-received a-C coated disc and after impacted at 100,000 impact cycles under different impact loads.

Raman spectroscopy is the best way to obtain the detailed bonding structures of the DLC films [10]. The Raman spectra shown in Fig. 3, which were taken from the surface layer of the impact craters, exhibit

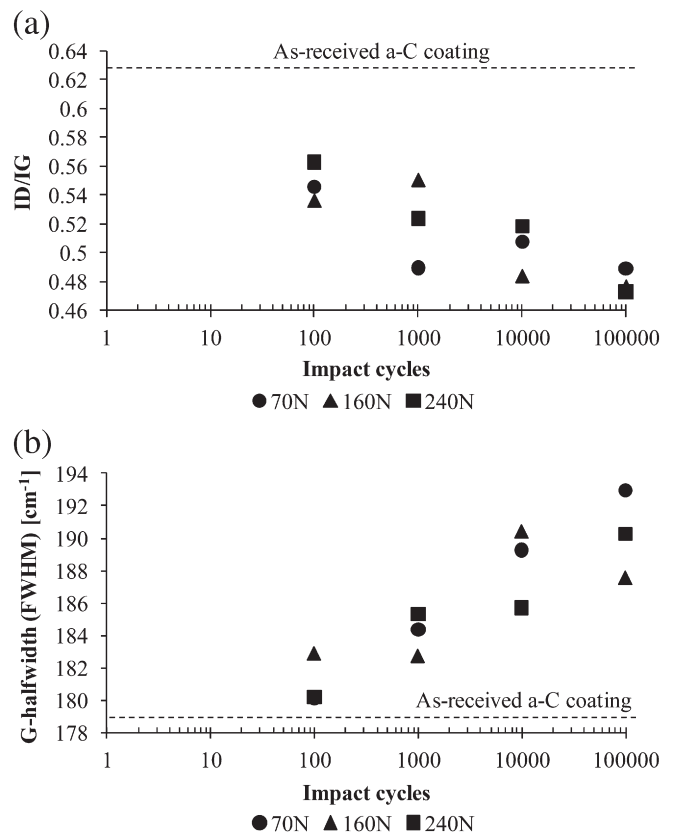
Fig. 4. Variation of (a) Raman intensity ratio ID/IG and (b) FWHM with impact cycles.
