Electron shading damage enhancement due to nonuniform in-hole etch rate in deep contact-hole process

Jeongyun Lee, Seok-Nyeon Kim, Dong-Hwan Kim, Ilsub Chung*

School of Information and Communication Engineering, Sungkyunkwan University, 300, Chunchun-dong, Jangan-gu, Suwon, Kyunggi-do, 440-746, Republic of Korea

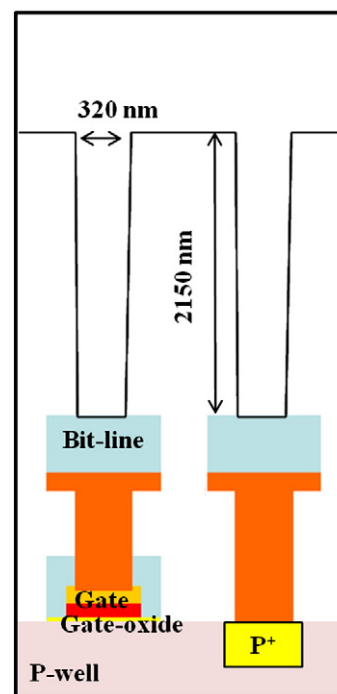
Fig. 1. Schematic diagram of the test wafer with the metal contact of DRAM.

A test wafer was prepared based on a DRAM device with metal contacts, as shown in Fig. 1. The depth and diameter of the metal contacts were 2150 nm and 300 nm, respectively. In an attempt to characterize the PPID on the gate oxide after etching the metal contacts in the DRAM device (See Fig. 2) SPDMs with antenna MOSCAPs which have areal antennas under metal-contact modules were used. In the contact antenna modules, the thickness of the gate oxide was 6 nm, the diameter of the metal-contact was 0.25 μm , and the depth of the metal contact was 1400 nm. The antenna-to-gate area ratios (A_f/A_g) were varied from 10 to 1200, where the fixed antenna area (A_f) was $100 \times 100 \mu\text{m}^2$. The gate oxides were, of course, completely shielded in the SPDMs. To characterize the gate oxide damage from the plasma process, SPDMs with antenna capacitors were tested by measuring the dielectric breakdown and Fowler–Nordheim (FN) tunneling current using a ramp voltage in the HP4156 system. Additionally, after curing at 430 °C for 30 min and removing the
