# Low velocity impact induced damage evaluation and its effect on the residual flexural properties of pultruded GRP composites

## Abstract

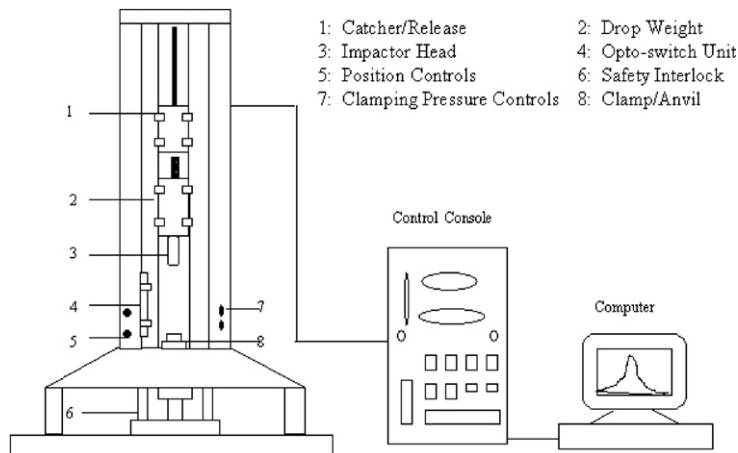
Fig. 1. Schematic of instrumented falling weight impact test machine.

Impact testing was implemented using an Instrumented Falling Weight Impact Test (IFWIT) machine. The general features of the equipment are schematically shown in Fig. 1. A controlled impact is achieved by dropping a chisel shaped striker which is attached to a weight in a defined manner from prescribed impact heights as shown in Fig. 2. The probe is equipped with a pizeo-electric transducer for measurement of velocity and load interaction between the probe and specimen. The velocity and load transducer provides a complete profile of the deformation response of the specimen during the impact process. Discrete values provided by the load transducer are collected and stored in a computer for post processing. A pneumatically operated mechanism switches on when the impactor bounces back to prevent the repetitive strike on the specimen. The specimen was pneumatically clamped between a 65 mm circular ring and anvil. Parameters such as energy, time duration, load, deflection and velocity are generated to characterise the impact events.
