# Fracture in complex balsa cores of fiber-reinforced polymer sandwich structures

Michael Osei-Antwi, Julia de Castro, Anastasios P. Vassilopoulos, Thomas Keller\*

Composite Construction Laboratory (CCLab), Ecole Polytechnique Fédérale de Lausanne (EPFL), Station 16, Bâtiment BP, CH-1015 Lausanne, Switzerland

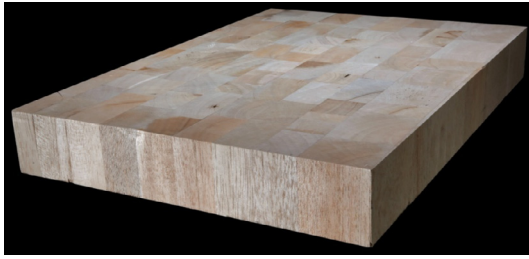
**Fig. 1.** Balsa panel composed of adhesively-bonded balsa blocks (dimensions 1200 × 1200 × 60 mm).

End-grain balsa panels are heterogeneous materials composed of similar sized blocks with a cross section of approximately 90 × 110-mm, as shown in Fig. 1, which are selected within a limited density range [7]. The balsa blocks of both higher and lower density are randomly assembled to avoid concentrations of softer blocks in the final panel. Assembly is performed by adhesive bonding using the frequently used thermoplastic polyvinyl acetate adhesive PVAc. Furthermore, inside a balsa block, density may significantly vary due to the cyclical changes of early and late wood [8]. Nevertheless, most of the few available studies on failure analysis of these materials assume the material as being homogenous [9,10]. The effects of the balsa block composition of the panels on the location, initiation and propagation of the cracks were not
