Physical characterization and compression tests of one leaf stone masonry walls

C. Almeida^{a,*}, J. Paulo Guedes^a, A. Arêde^a, C.Q. Costa^a, A. Costa^b^a Department of Civil Engineering, University of Porto, Porto, Portugal^b Department of Civil Engineering, University of Aveiro, Aveiro, Portugal

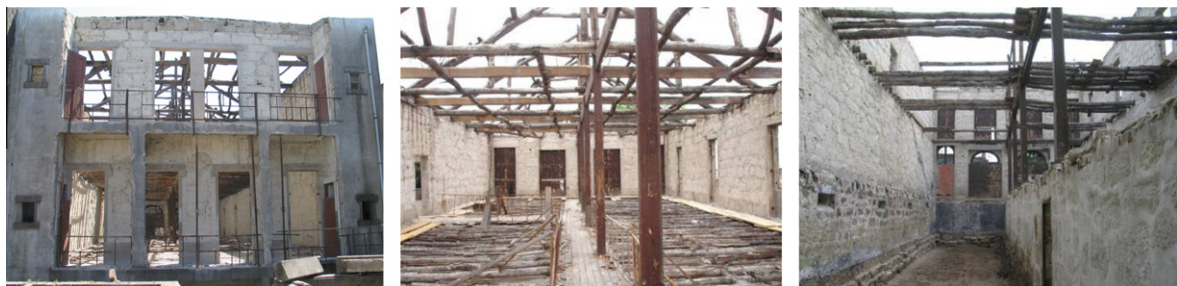
Fig. 1. Rehabilitation works in the studied building.

At the time of this study, the building was under rehabilitation. The foreseen intervention included the demolition of the internal structural wall in floor -1, the opening of new doors in some of the remaining walls and the removal of the cover mortar, see Fig. 1.
