Effect of axial loads in the seismic behavior of reinforced concrete walls with unconfined wall boundaries

C. Alarcon, M.A. Hube*, J.C. de la Llera

Department of Structural and Geotechnical Engineering, Pontificia Universidad Católica de Chile, and National Research Center for Integrated Natural Disaster Management CONICYT/FONDAP/15110017, Vicuña Mackenna 4860, Santiago, Chile

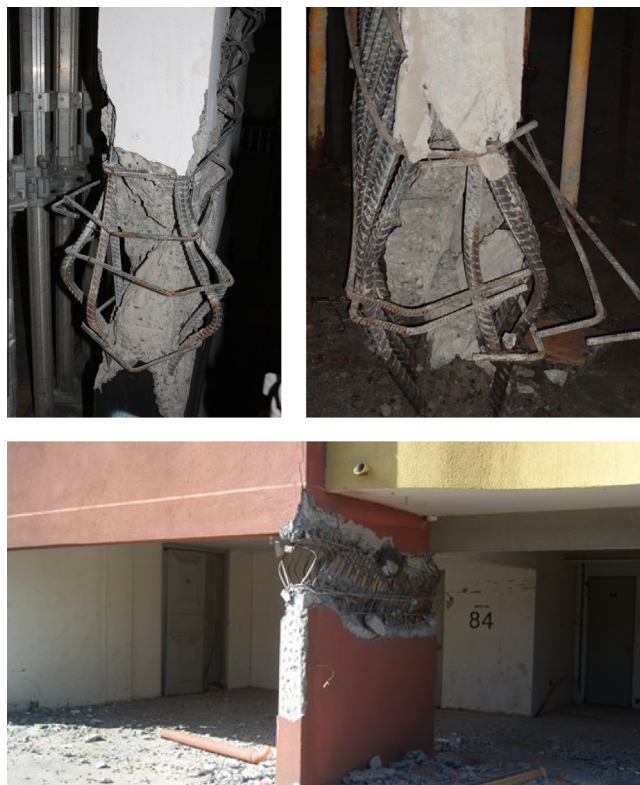
Fig. 1. Typical flexural-compressive failure of RC walls during 2010 Chile Earthquake involving crushing of concrete, vertical reinforcement buckling, and horizontal reinforcement opening.
