Do Magnetic Resonance Imaging Technologists in Canada Always Ask Patients to Change Before Examinations?

Helen Heng Yang MRT (MR) (R)*, Melissa F. Charette MRT (MR) (R), BSc, and
Nancy Talbot MappSc, MRT(MR) (R)

Joint Department of Medical Imaging, University Health Network, Toronto, Ontario, Canada

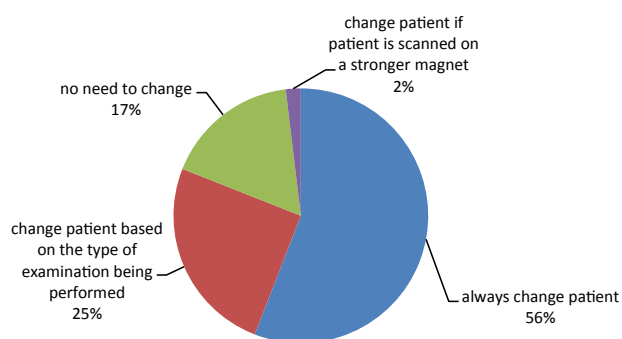
Figure 1. Technologist practices distribution pie chart.

Results demonstrated that when patients arrived for an MR scan wearing a plain T-shirt and stretch pants, 56% of technologists would ask them to change into hospital attire (regardless of what the patient was wearing). Twenty-five percent would ask patients to get changed based on the type of examination to be performed. Since there was no metal on the patient, 17% of technologists would not ask them to get changed. At last, 2% would only ask patients to get changed if their examination was planned for a stronger magnet (see Figure 1).
