## Void-induced liner deformation and stress redistribution

Voids behind the liner may be created during or after construction of the tunnel liner because of insufficient backfilling, poor workmanship, water erosion or gravity. Survey on a number of tunnels that suffered collapse while in service showed that voids behind the liner were the main factors for the failure. The paper provides a better understanding of the stress redistribution that occurs in the rock mass around a void and quantifies the stresses induced in the liner due to the voids. The effects of cavities or voids due to different size, location and depth are explored numerically through an elasto-plastic finite element analyses. Other factors such as lining flexibility, in situ stresses and tunnel shape are also investigated. The analyses show that voids can induce a large change of the thrust and bending moment in the liner with respect to the case of a liner without a void. The bending moment can even reverse sign, which may result in cracks in the lining or even failure. The voids also change the distribution of the rock stresses around the tunnel, which may result in progressive failure of the rock and rock fal

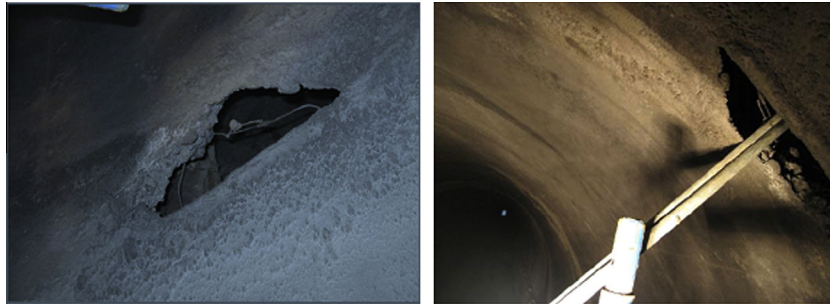
Fig. 1. Photographs of voids behind the tunnel lining (Liu, 2007).

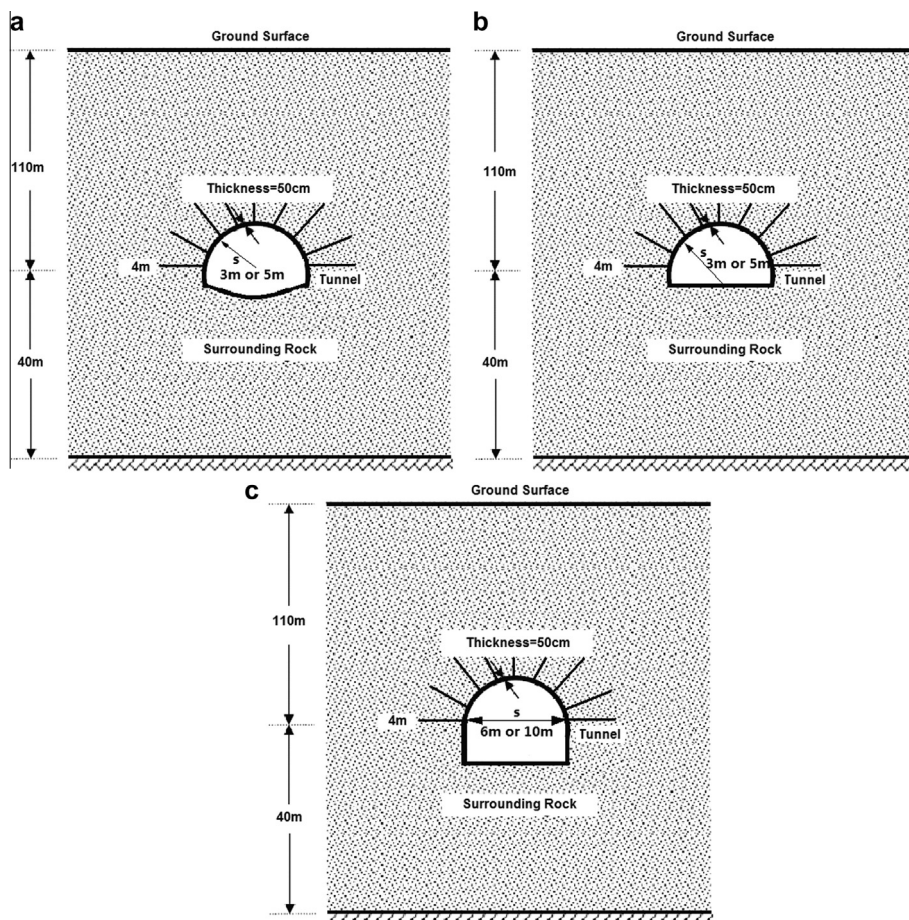
Fig. 2. Tunnel geometry used in numerical simulations. (a) Section 1: semicircular tunnel with invert; (b) Section 2: semicircular tunnel without invert; (c) Section 3: horseshoe tunnel.
