Effectiveness of a barbed suture in the repair of bile duct injury during laparoscopic cholecystectomy: Report of two cases

Yusuke Takahashi*, Naoyuki Yokoyama, Natsumi Matsuzawa, Daisuke Sato, Tetsuya Otani

Department of Digestive Surgery, Niigata City Hospital, Niigata, 950-1197, Japan

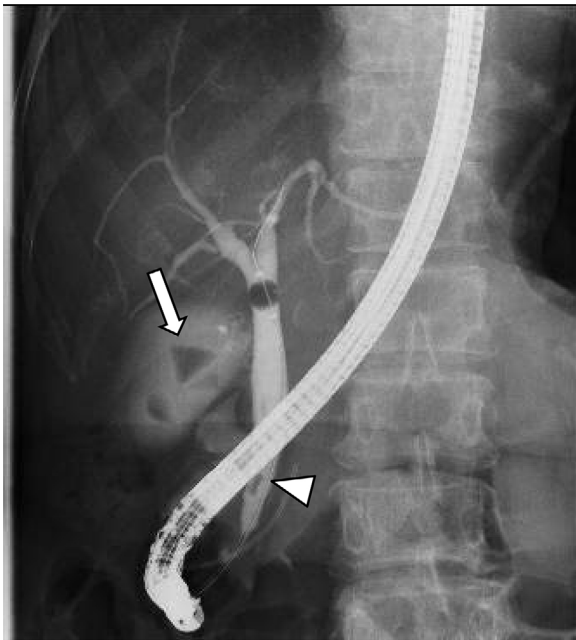
Fig. 1. Endoscopic retrograde cholangiography showed gallbladder stone (arrow), and common bile duct stones (arrow head). Anatomical variations of the biliary tract were not evident.

A 73-year-old woman undergoing postoperative breast cancer treatment was found to have asymptomatic gallbladder and common bile duct stones on computed tomography (CT). After endoscopic sphincterotomy for choledocholithiasis, without any evident anatomical variation of the biliary tract in the endoscopic retrograde cholangiography, the patient underwent elective LC for cholecystolithiasis (Fig. 1).

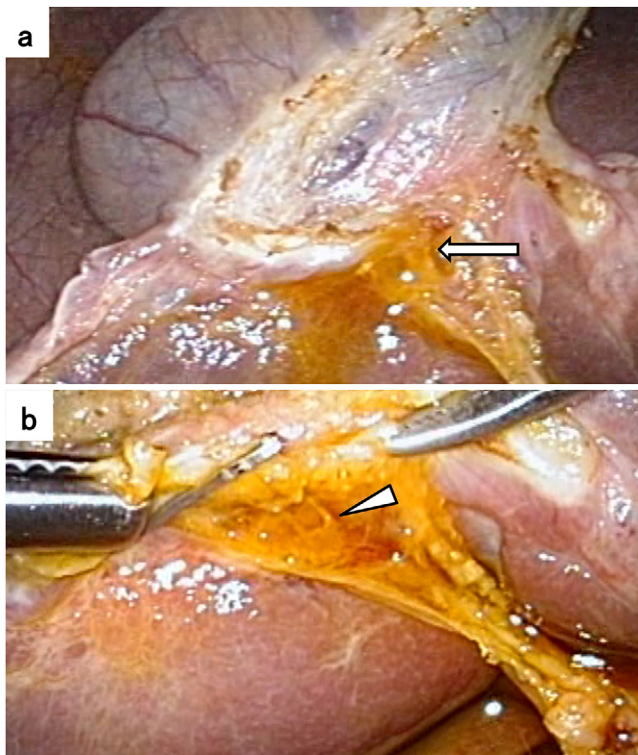
Fig. 2. Intraoperative findings: a) Bile spillage (arrow) was present in the gallbladder bed during gallbladder dissection, b) The injured small bile duct was evident (arrow head). Repair using a titanium clip was unsuccessful.

diameter of about 1 mm was detected (Fig. 2a,b). We considered performing cholangiography from the injured bile duct; however, the bile duct was too thin and narrow to perform cholangiography. We initially tried to repair the injury using a titanium clip. However, the clip could not fully close the injured bile duct owing to limited maneuverability. Moreover, we were concerned that a non-absorbable foreign body such as a titanium clip could be the nidus
